RIVER HABITAT AND MACROPHYTE SURVEYS IN POLAND

RESULTS FROM 2003 AND 2007

A report by Paul Raven¹, Nigel Holmes², Peter Scarlett³,
Krzysztof Szoszkiewicz⁴, Agnieszka Ławniczak⁴ and Hugh Dawson³

March 2008

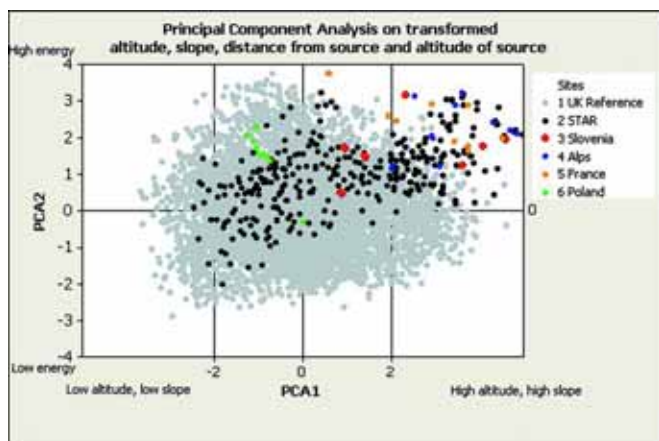
Figure 1. PCA plot, showing Polish sites in relation to UK, STAR and European benchmark sites.

Figure 1 is a PCA plot, showing the Polish sites compared with those in previous surveys^{18,20}, STAR project sites⁴ and UK baseline sites⁶. It graphically illustrates the extremely low gradient nature of the rivers.

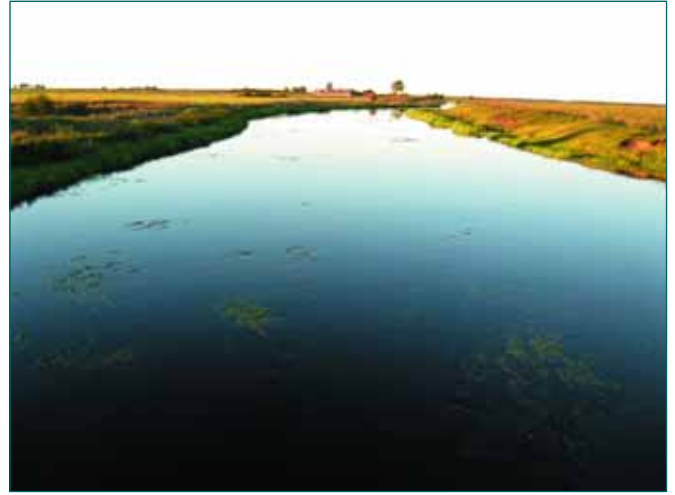
The Kan Rudzki - a major drainage channel that takes most of the flow from the Elk River 15 km upstream from PL-13.

The importance of ground-truth surveys to test assumptions made from maps and aerial photographs was illustrated by our surveys of the Jegrznia and Elk rivers (PL-12 and PL-13). Images of extravagant meanders and relic channels suggested good potential for near-natural conditions; in reality, however, two major drainage channels (the Kan Rudzki and Kan Woznawieski) effectively take virtually all the stream energy from both river systems leaving them hydromorphologically moribund. There are also few riparian habitat features because the floodplain is either grazed or regularly cut for hay.

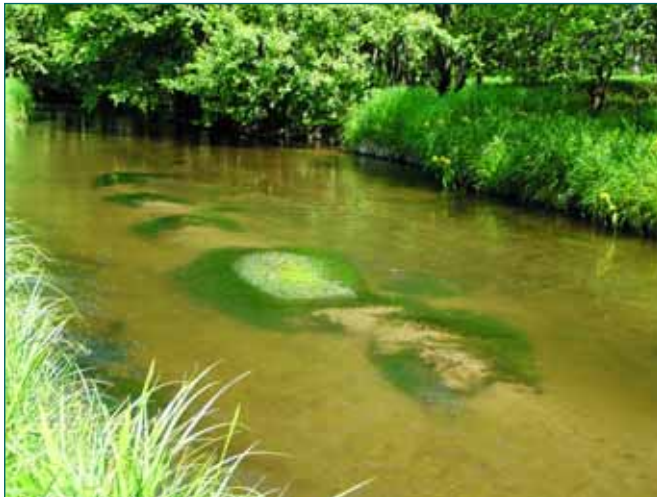
Growth of *Ranunculus circinatus* can create large mounds of sand on river beds; PL-1.

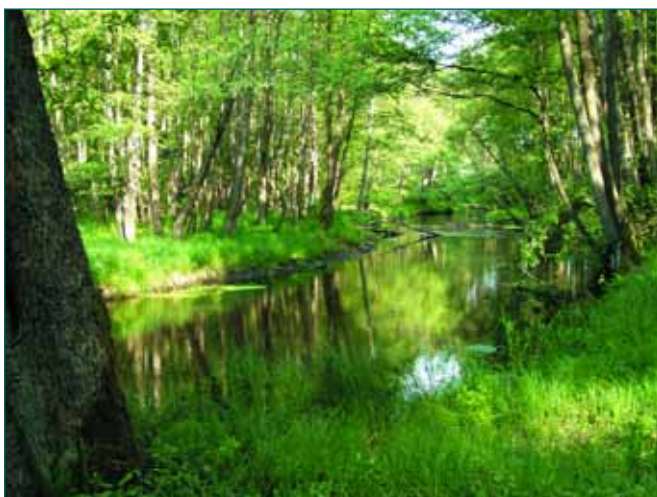
Low flow conditions reveal silting along the water's edge; PL-2.

The Dobrzyca rises seven km north-east of Czaplonek. At PL-2, some 65km downstream it is a small, heavily-shaded river, with a sand substrate. Low flow conditions during our survey revealed extensive silt along the margins, probably a consequence of forestry management such as logging. Alders (*Alnus glutinosa*), wet woodland and fen provide the main wildlife interest. The site contained a STAR project⁴ macroinvertebrate sampling site.

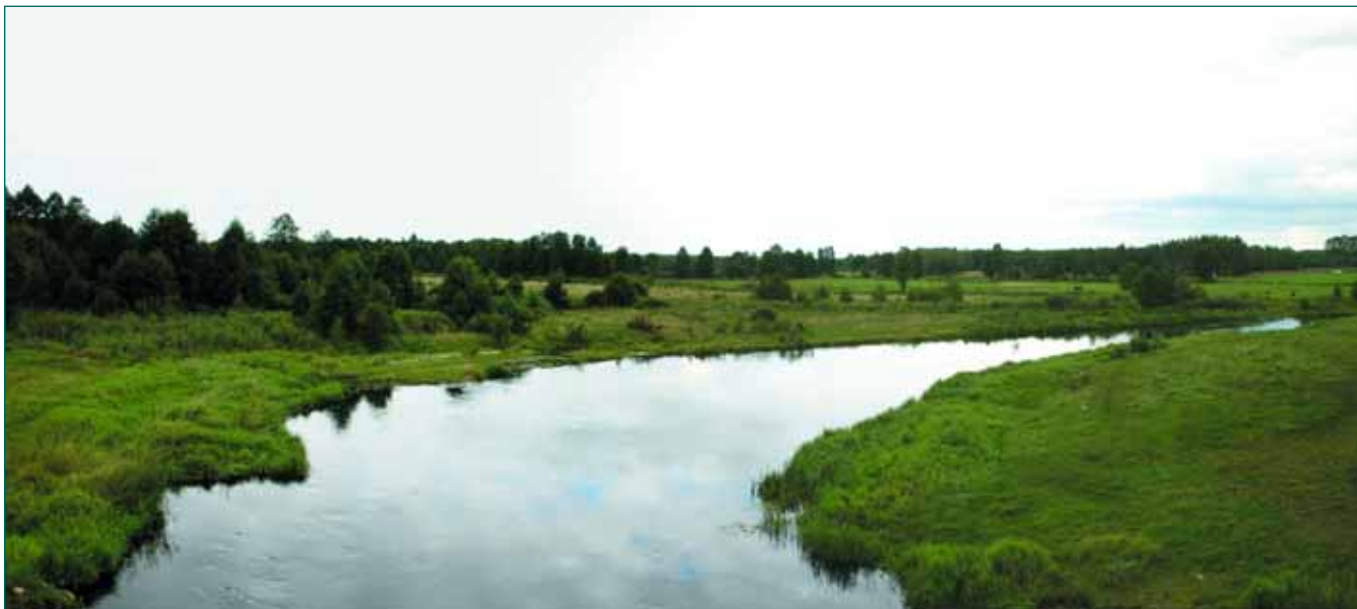
Natural berm/terrace features, plus a small wetland marking an old cut-off channel on the left; PL-10.

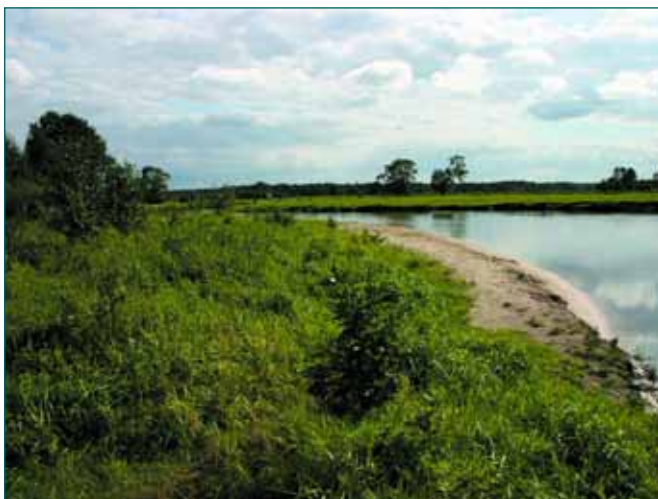
Actively meandering channels produce sandy point bars, with natural berms forming behind; PL-10.

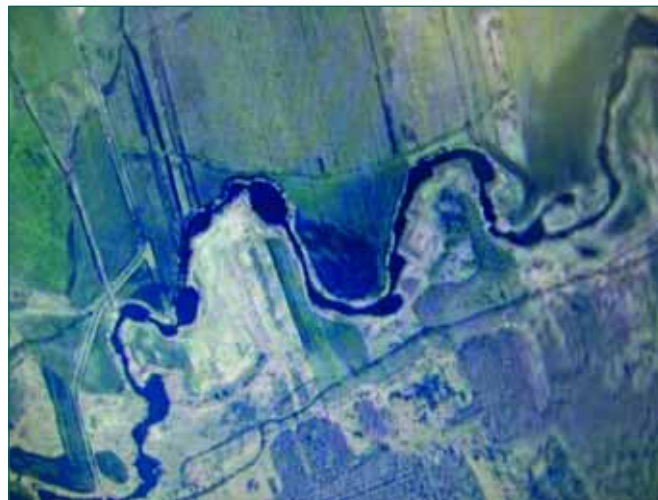
Google Earth image of the Jegrznia, showing "necklace" pattern of narrow channels and wide pools; PL-12.

The Jegrznia has enlarged circular open water patches, with narrower reed-infested 'necks' in between; this produces a necklace pattern. Apart from a solitary mature alder in PL-13 there are no bankside trees at either site, emphasising the man-made nature of the landscape. This is typical of the Biebrza National Park rich-fen meadow (grazed or cut in the summer), with reed-filled relic cut-off channels, and occasional woodland and scrub.

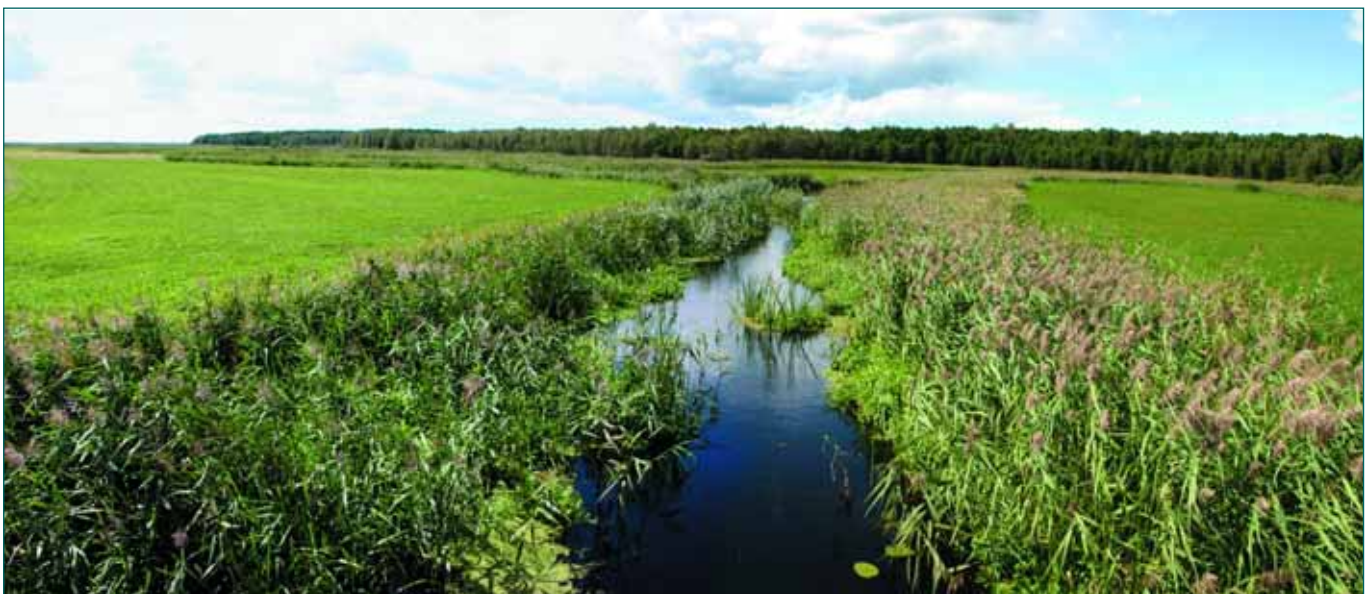
Reed-fringed channel and recently-cut fen; Jegrznia river near PL-12.

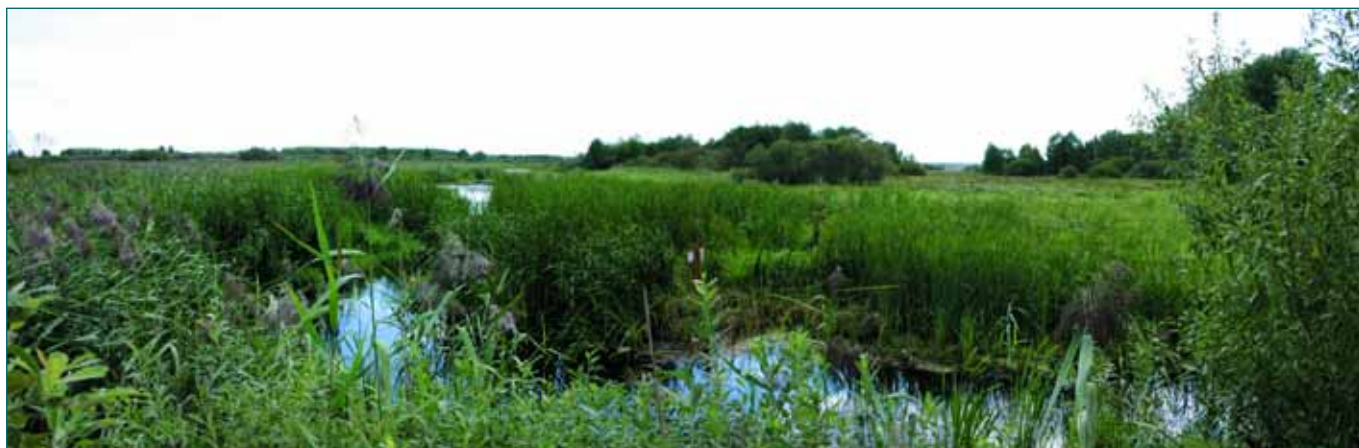
In multi-thread channel and reedbed areas, it is essential to use aerial photographs.

It is recommended that densely reed-lined channels and backwaters are surveyed using aerial photographs and a boat or canoe (‡). Spot-checks every 50m could be estimated using calibrated range-finders or GPS, with substrate in the channel and bank at spot-checks determined using a ranging pole, plumb-line or, in very deep channels, an echo-sounder.

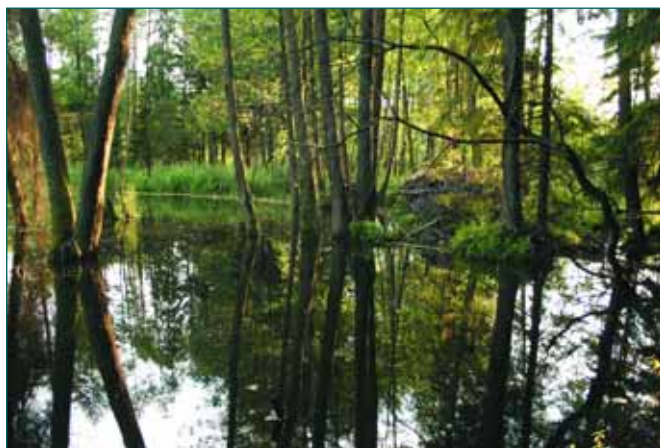
Naturally impounded water caused by a beaver dam.

It is recommended that natural impoundment (e.g. beaver dams, temporary dams caused by flood debris) is recorded in the sweep-up. We suggest "naturally impounded water" is inserted after 'marginal deadwater' and before 'eroding cliffs' on the list of channel and bank features in Section K. Surveyors would then be able to include present or extensive impoundment caused by beaver dams or temporary flood debris.

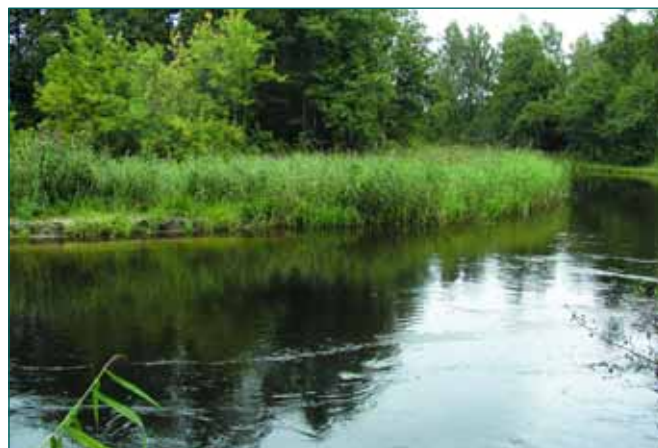
Active meandering produces extensive natural berm and terrace features in many Polish rivers.

It is recommended that the diagram of natural berm and terrace formation in actively-eroding channels (Figure B9 in the manual) is repeated alongside the sequence in Figure E4 to offer direct comparison with the process of natural recovery in over-widened, modified channels.
