RIVER HABITAT SURVEY IN SLOVENIA

RESULTS FROM 2005

A report by Paul Raven¹, Nigel Holmes², Hugh Dawson³ and David Withrington⁴

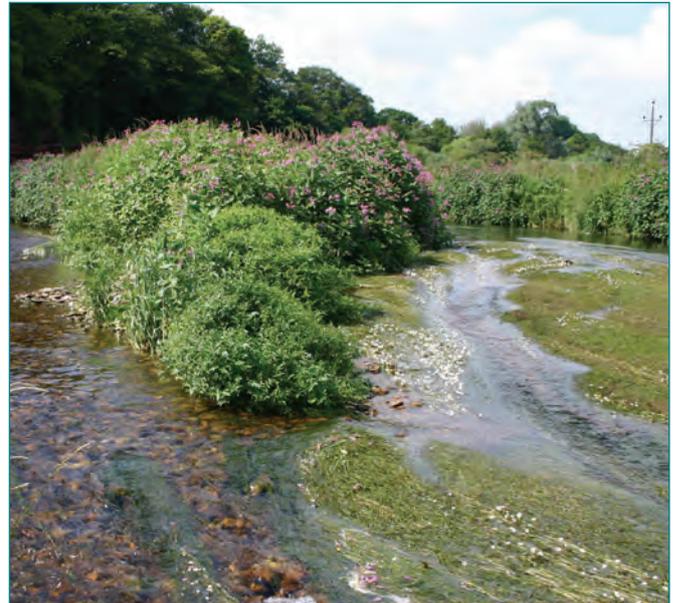
Features such as vegetated mid-channel bars contribute to HQA scores

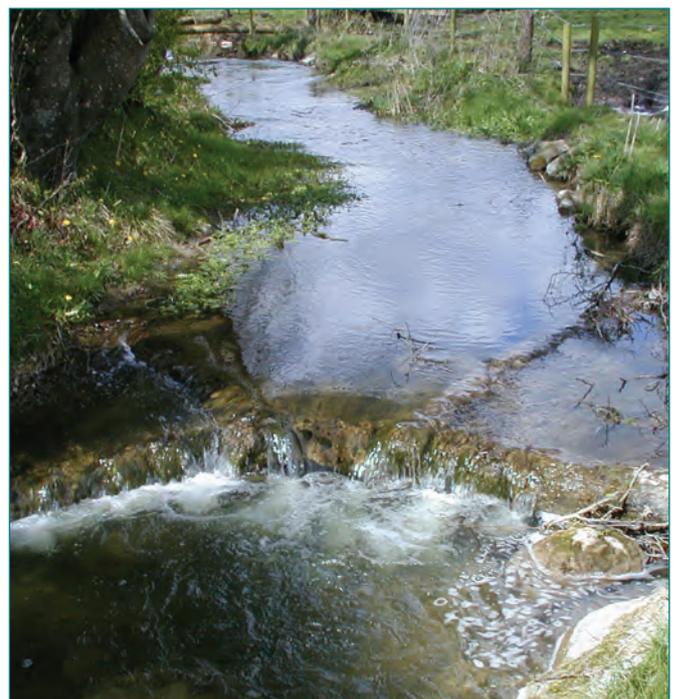
Artificial changes to channels, such as weirs are negative features in the HMS system

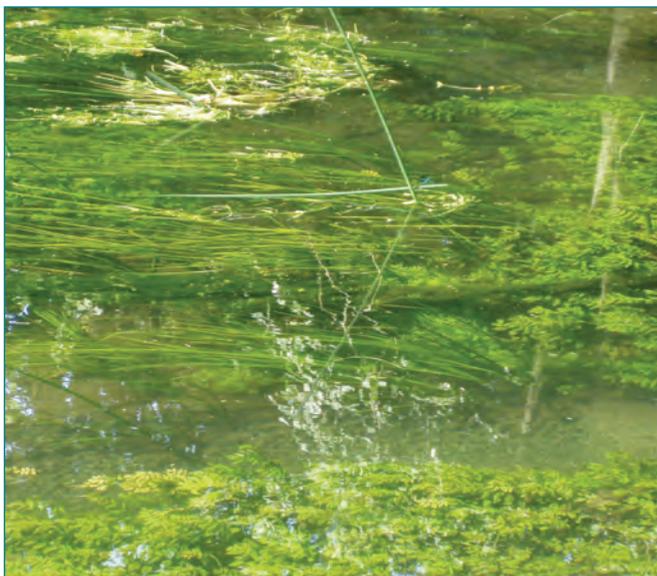
Only aquatic plants are surveyed in the MTR system

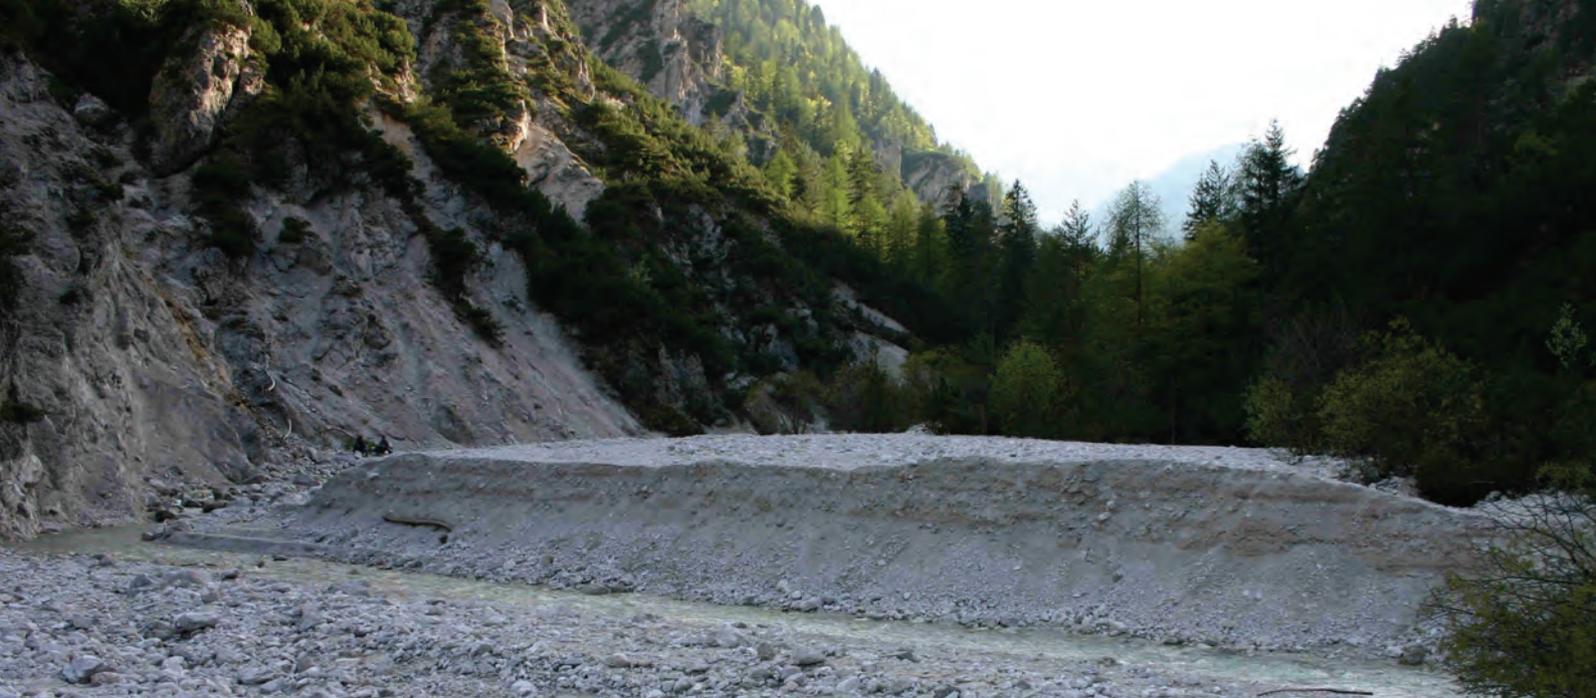
Deep deposit of material carried by the Pišnica River

Downstream of SLOV-2, on the Pišnica River, there were several metres of recently deposited sediment within its floodplain reach, representing material transported by the river derived from landslips following heavy rain.

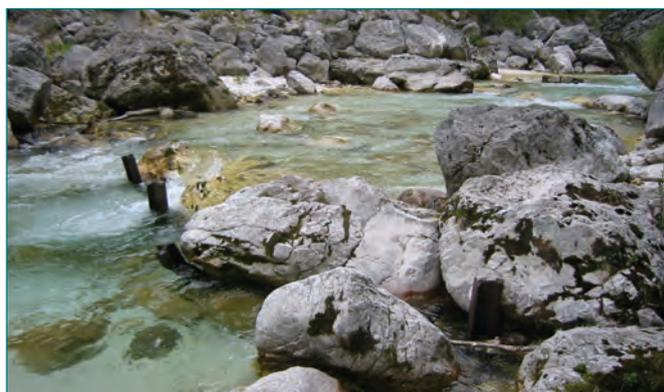
Bed and bank stabilization on the Soča, using steel pins

SLOV-3 was located on the River Soča where it flows alongside a major road. The river has been modified through bank protection and bed reinforcement, using local materials. Large boulders (rip-rap) have been secured with a small amount of concrete and, in the channel, iron pins. However, to the untrained eye, this would look little different to a 'natural' river.

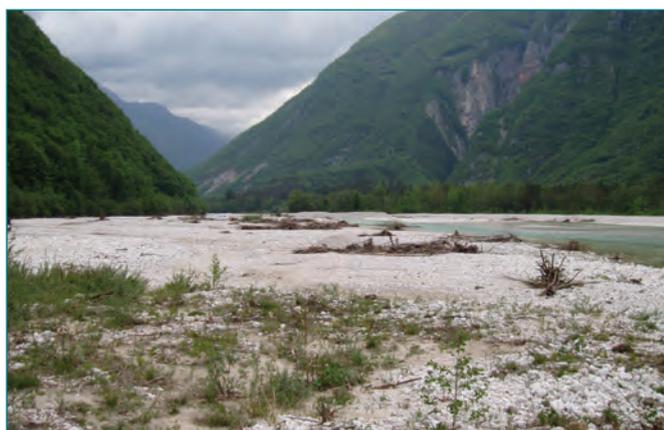
The highly mobile, braided, section of the Soča

A wide, braided section of the Soča River (SLOV-4, 5) near Bovec was surveyed (albeit in a cursory way given time constraints), and this illustrated the typical characteristics of a highly mobile river in the wide, flat bottom of a glaciated alpine valley.

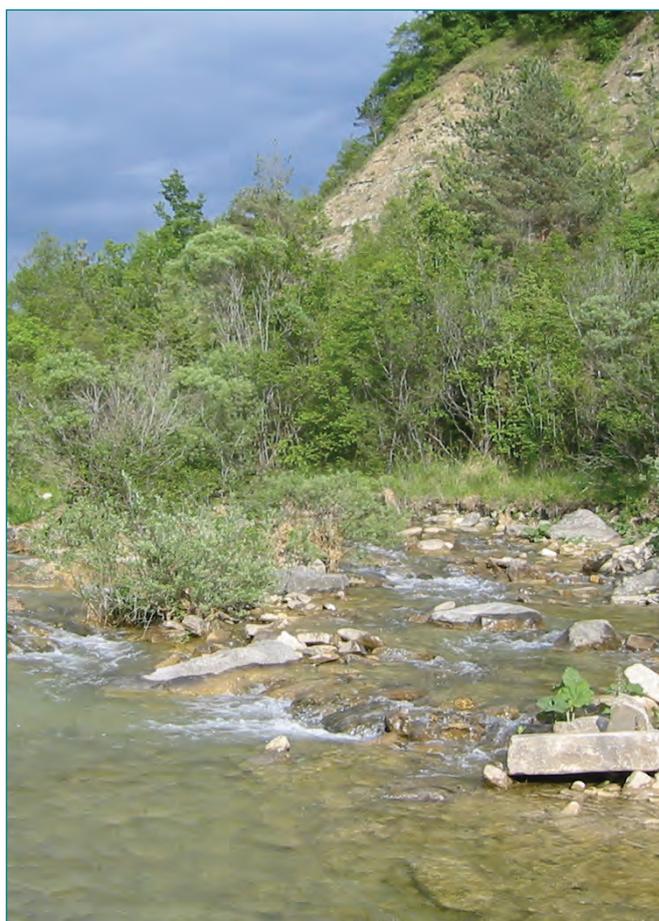
Herbaceous plants and shrubs growing in mid-channel of the intermittent Dragonja River

The Dragonja River (SLOV-10, 11), close to the Croatian border, is a bedrock-dominated river which has a diverse riparian habitat and illustrates the effects of seasonal flow in the sub-Mediterranean region of Slovenia.

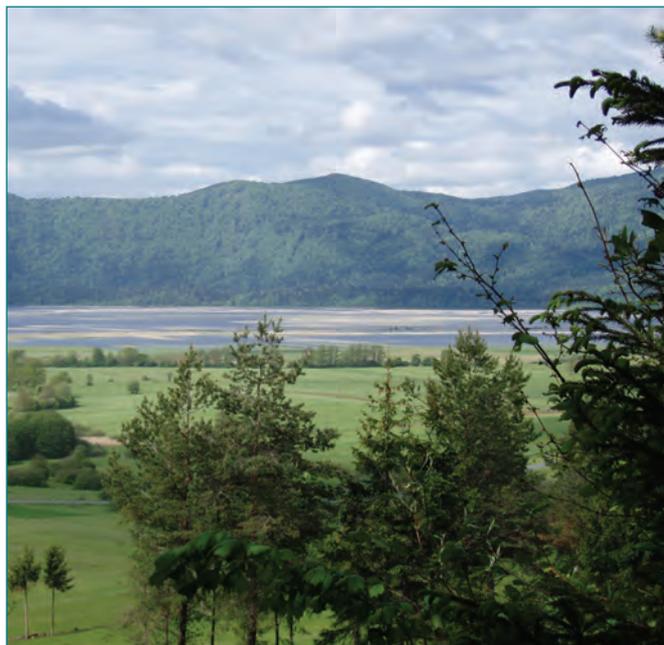
The Obrh (SLOV-6 to 9) is a low gradient river in a karstic landscape and flows into the seasonal lake Cerčniško Jezero. It has a marked two-stage natural channel reflecting the great variation in seasonal flow. This seasonality is confirmed by the rarity of true aquatic macrophytes in the channel.

Cerknjško Jezero, the seasonal lake into which the Obrh flows

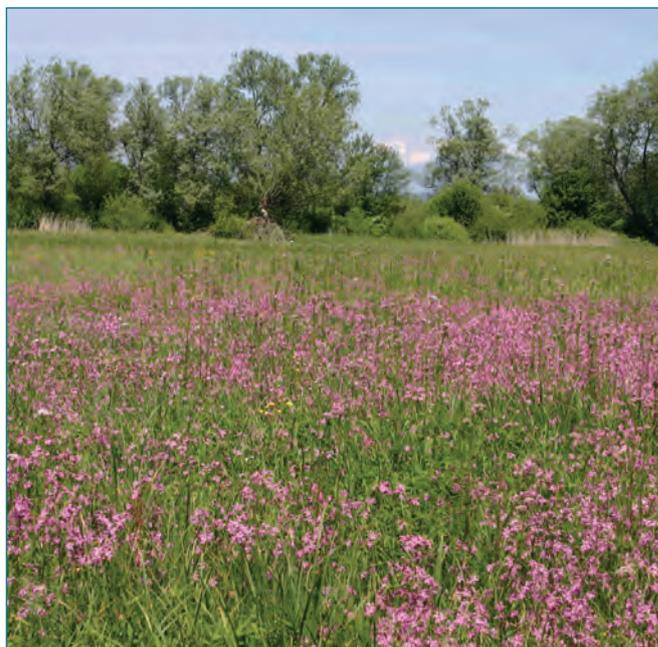
The Iziča River (SLOV-12, 13), south of Ljubljana, has a negligible gradient and flows through agricultural peatlands. Evidence suggests that the surveyed reach was recovering geomorphologically from historical overwidening and deepening, although this has yet to be

confirmed. As with the Obrh, a very rich wetland flora on the floodplain is the result of low intensity hay meadow management.

Herb-rich grasslands and wetlands are a feature of the Iziča floodplain

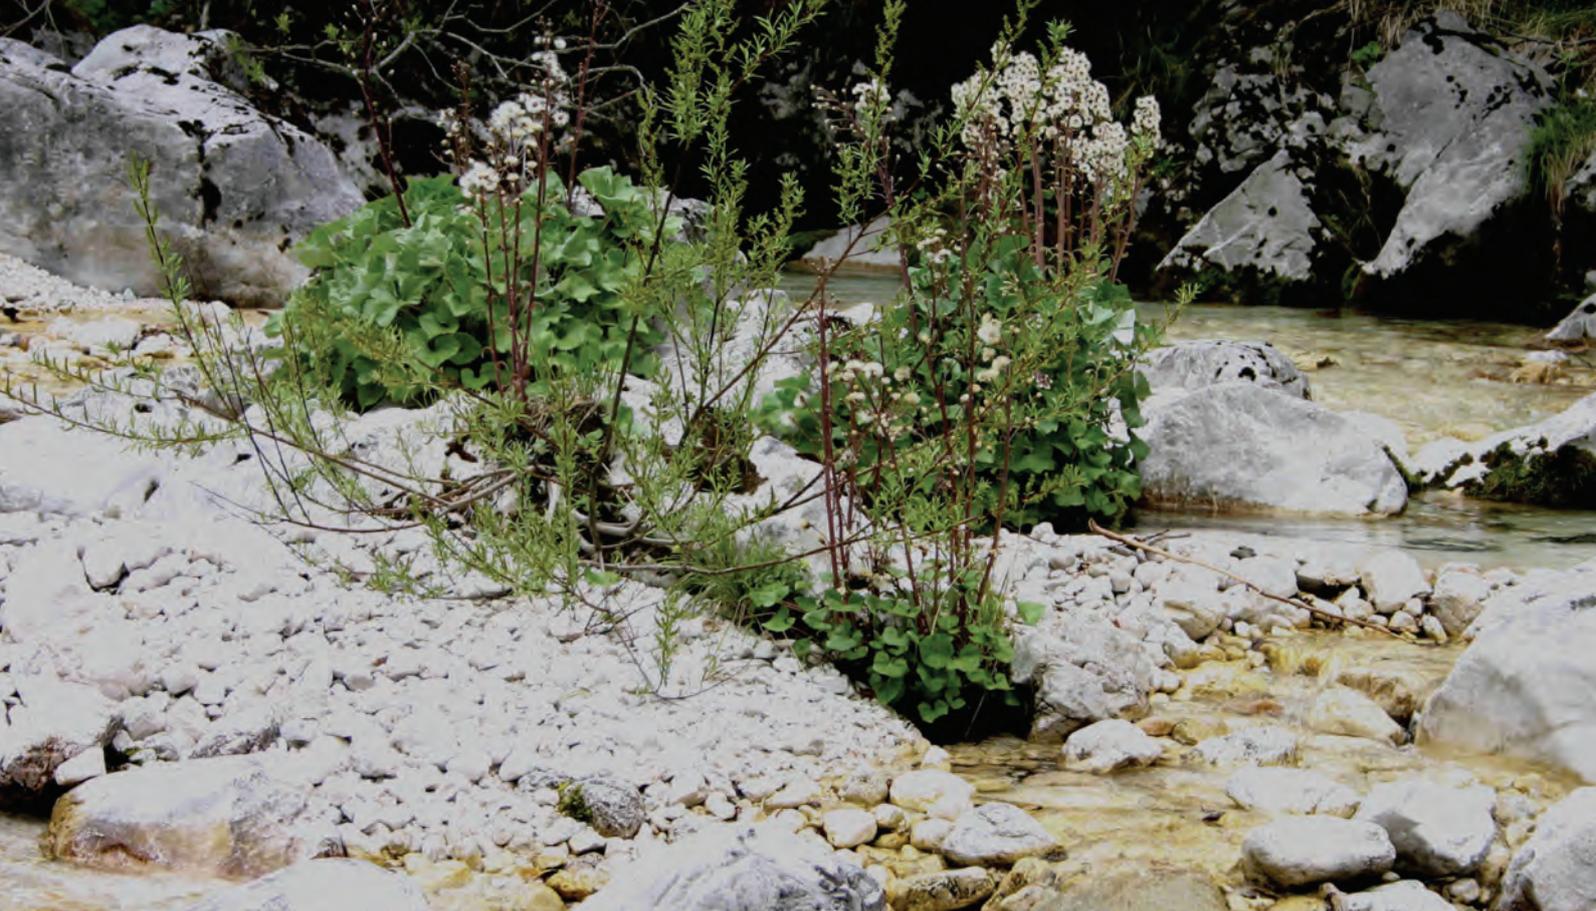
The banks and gravel bars of most alpine rivers support rich communities of bryophytes and higher plants – *Petasites* is especially prevalent

The Pišnica River was characterized by an almost total lack of macrophytes; it was noteworthy for extensive boulders and gravel transported by floods following earthquakes and land-slips. The Alpine rivers (e.g. Bistrica and Soca) had rich flora associated with boulder bars, dominated by *Petasites* and alpine species rare or absent in the UK.

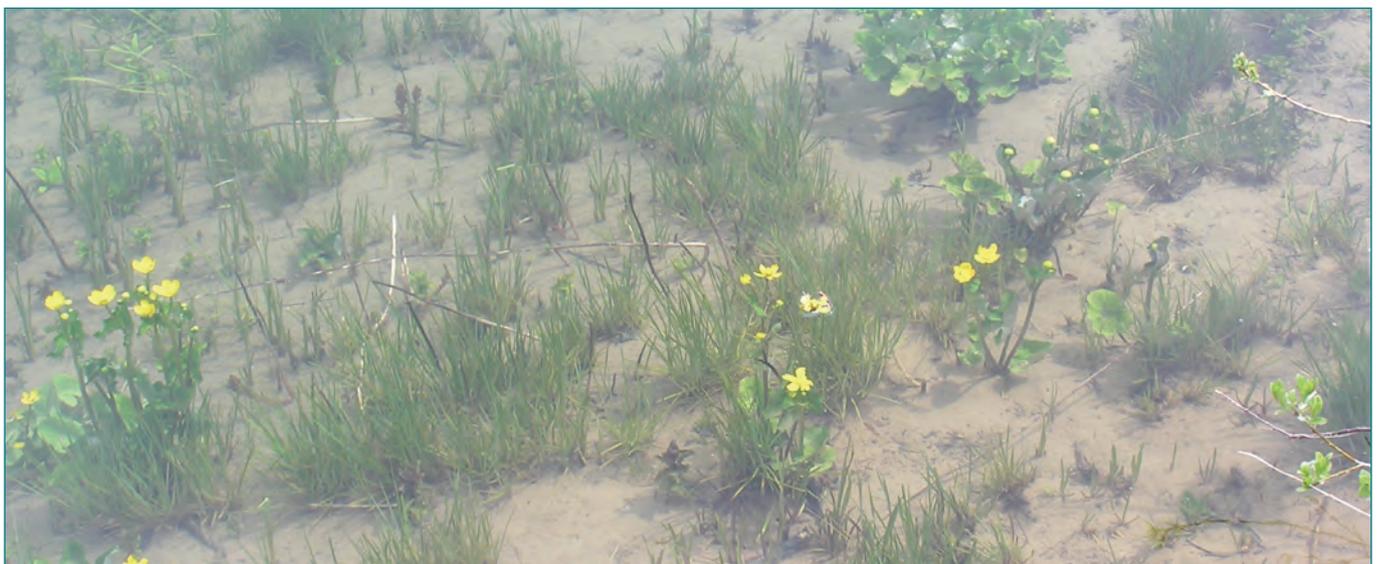
The Obrh River had an especially interesting flora that indicates periodic autumn drying and high flows in spring and summer. The growth of *Caltha palustris*, growing like water lilies, is similar to that observed from meltwater rivers in Finland.

Caltha palustris, flowering underwater in the Obrh

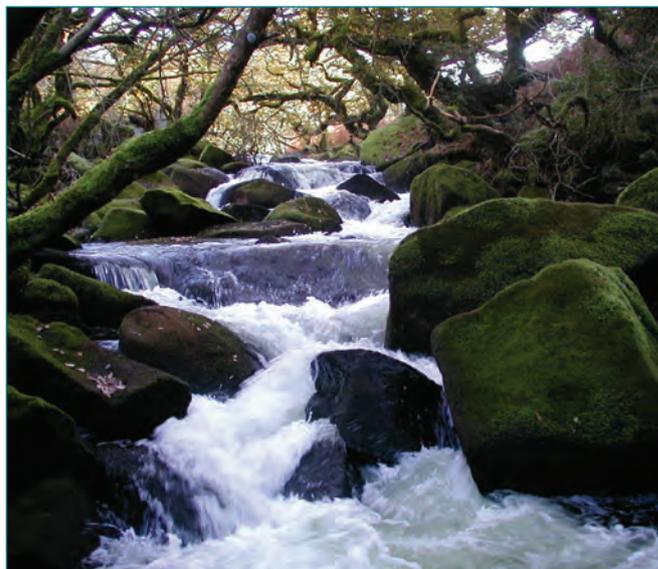
The DeLank River in S-W England is typical of upland, wooded, valleys; the lower gradient and altitude results in more bryophyte growth

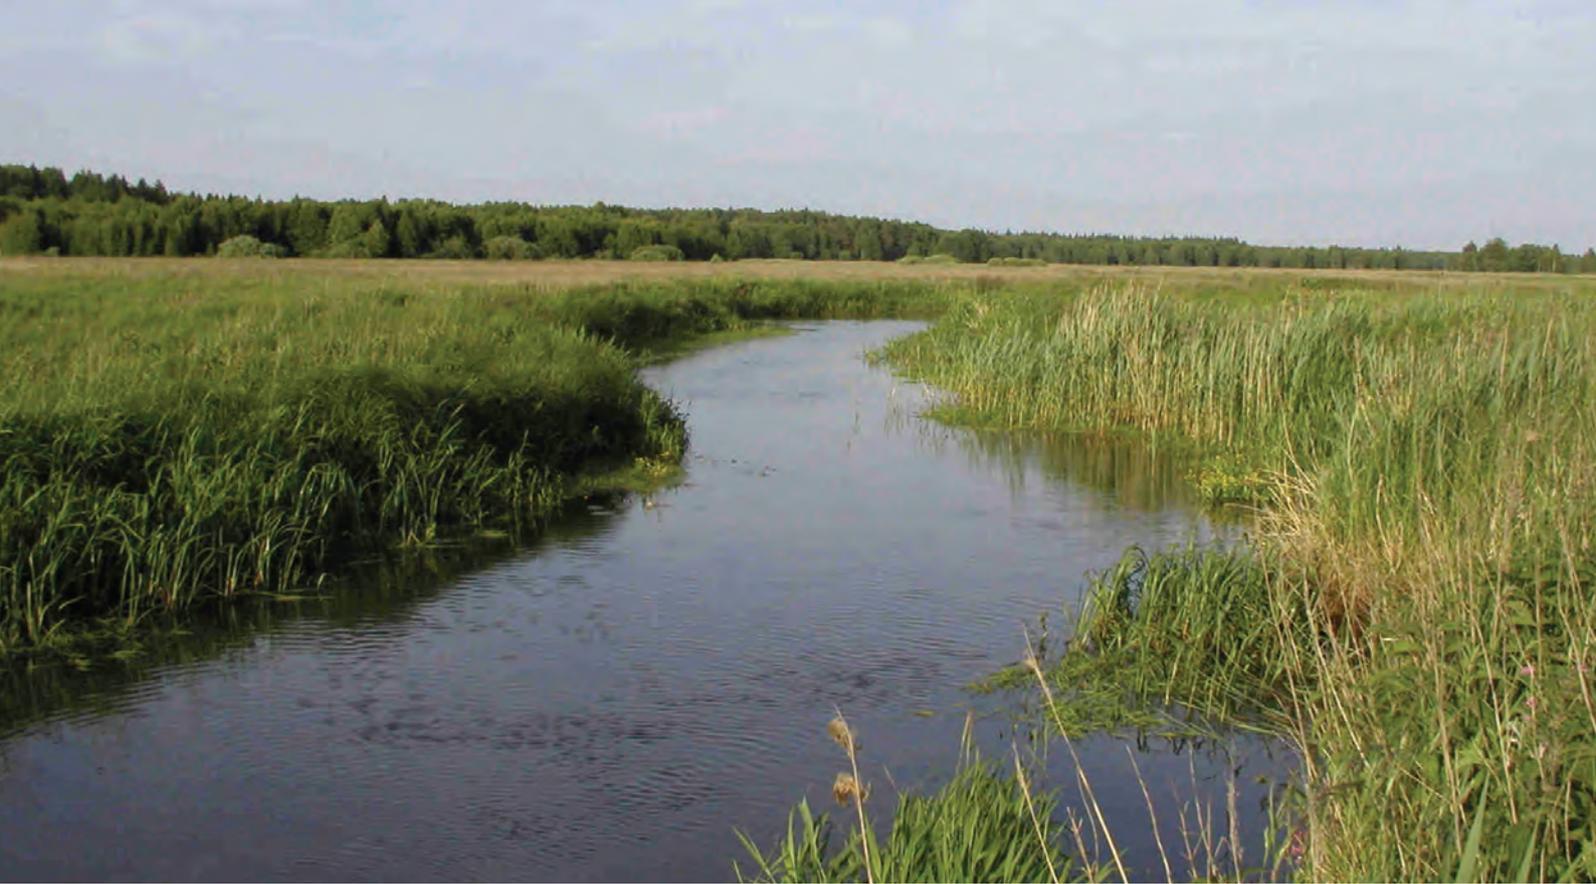
The River Narew, Poland, has many characteristics similar to the Obrh

The low gradient Obrh (SLOV-6 to 9) is broadly comparable with the River Brathey in the English Lake District, but with a distinctive, natural, two-stage channel structure and rich meadow flora. In this respect it is closer in character to the Narew River in NE Poland, surveyed in 2003. Corncrakes and marsh harriers were recorded along the Narew in 2003, as they were for the Obrh in 2005. The Obrh is distinct in naturally drying in most autumns, and therefore having a flora more akin to the winterbournes which form the headwaters of English chalk rivers.

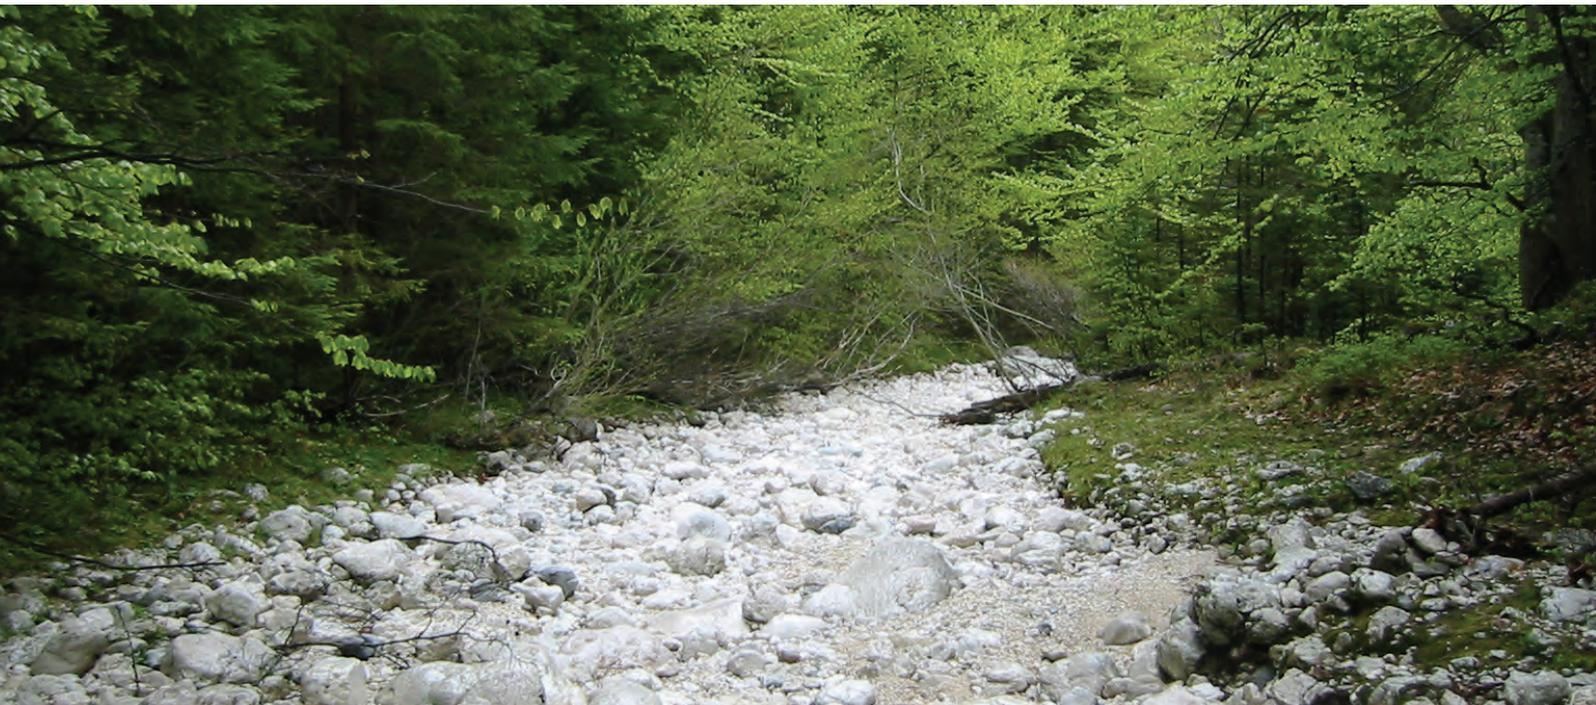
Many kilometres of the channel upstream of the surveyed site were dry, even in May

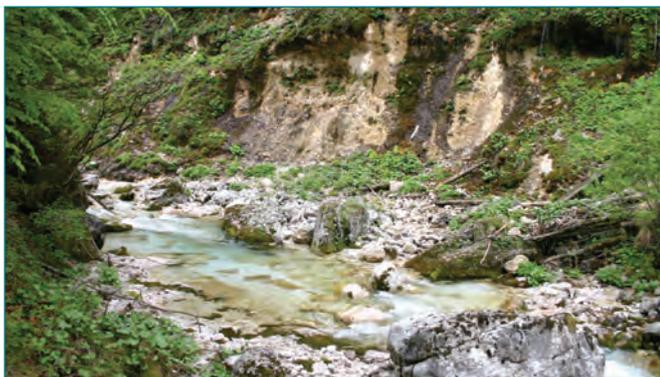
Loose sediment is released into the river from the eroding steep valley sides

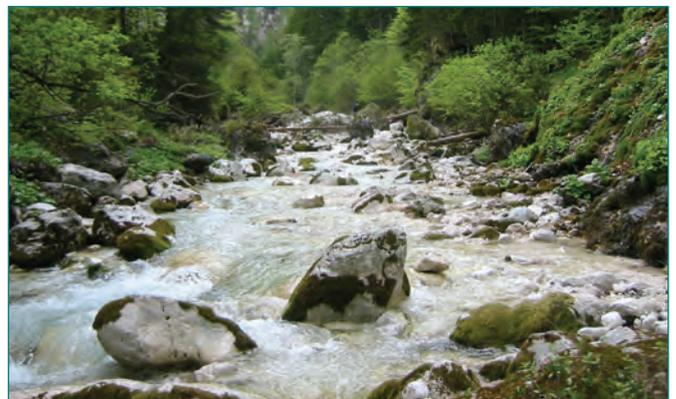
Mixed boulders and cobbles dominated the bed within the site; wooded valley

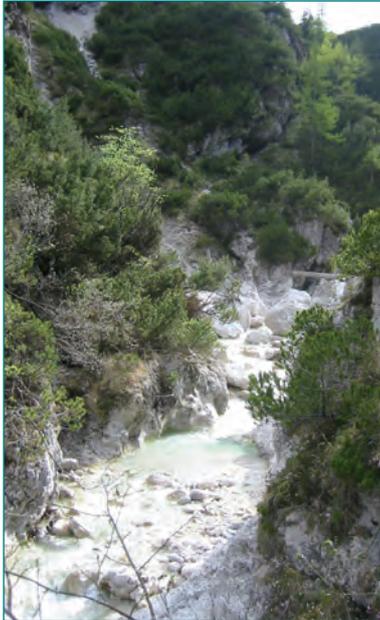
A clear-water torrent river in a steep wooded alpine ravine. Virtually no aquatic macrophytes, presumably because of huge scouring force of meltwater, storm flows and possible effects of rock debris carried down the valley after recent earthquakes or torrential rain. Very narrow (<10m wide) gorge widens out after 250m, allowing enormous boulders to be deposited.

From torrent flows through an upstream gorge, the river gradient shallows, and the valley floor widens

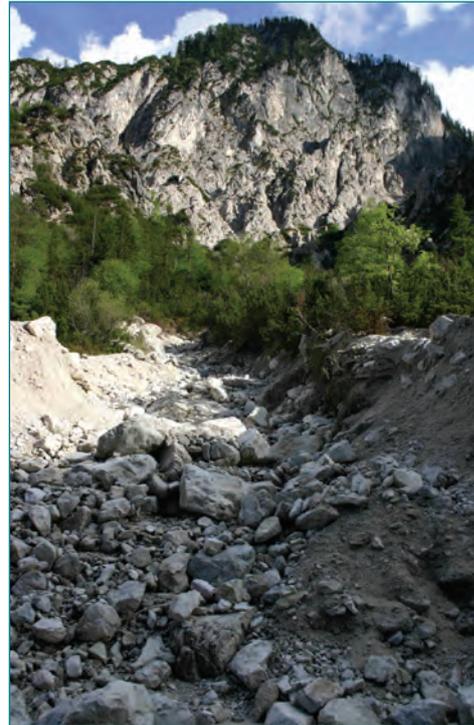
A tributary entering the RHS also has been subject to enormous throughput of material brought down from upstream

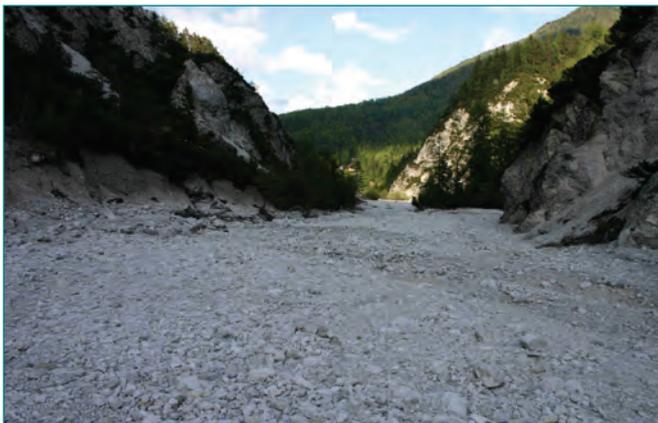
Following a recent landslide, huge deposition of material has taken place in the lower part of the site, and downstream

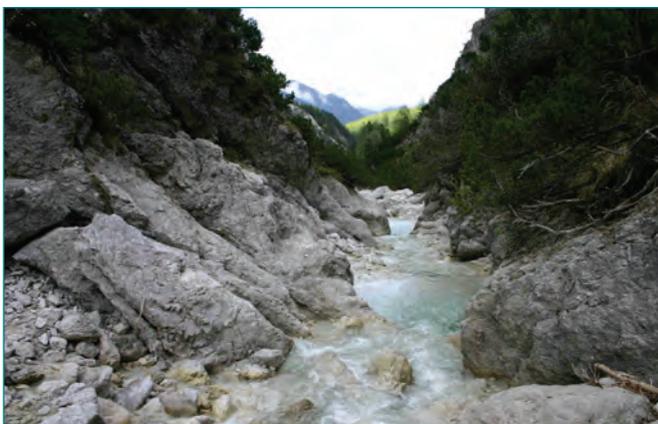
Due to scour, as above, or being covered by recent deposits, vegetation within the river was virtually zero

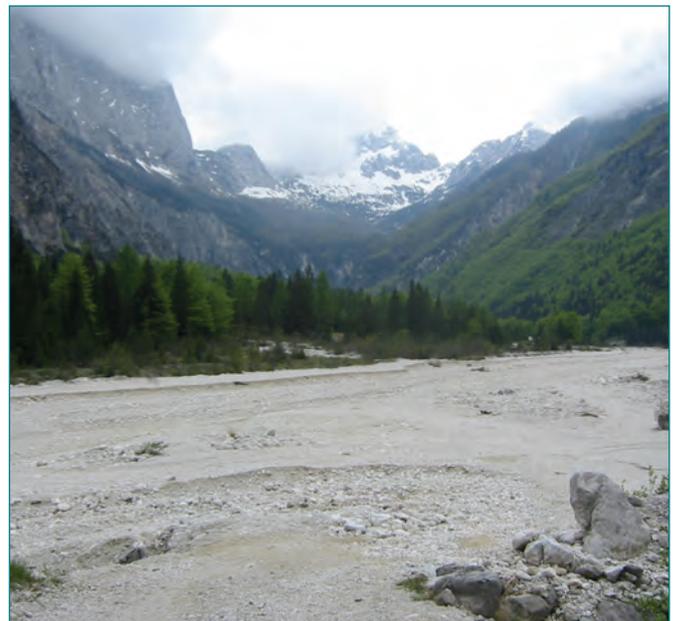
The dry River Trenta, upstream of the surveyed site

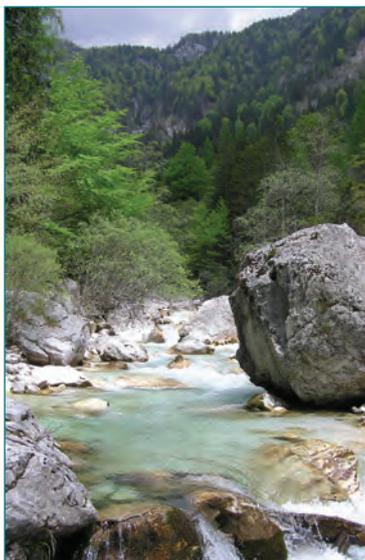
Because of the proximity of a major road, the right bank is stabilised by large boulders being concreted together in places (and consequently recorded as rip-rap). Several stanchions and pins have been placed in parts of the river channel to stabilise the boulders and form boulder groynes. A small suspension bridge for walkers is located at the downstream end. Nevertheless, the overall impact of these modifications on river ecology (migration of fish, channel and bank habitats) and landscape is likely to be minor.

Despite some stabilization measures, the overall appearance is of a very natural stream

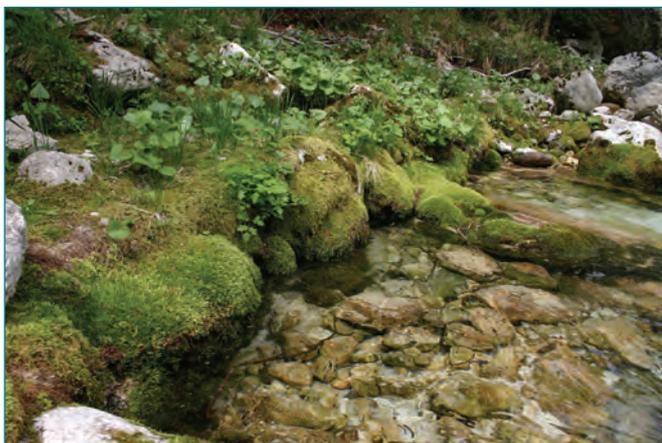
A rich marginal flora, dominated by bryophytes, was a feature of the site

The MTR of 70 indicates high quality, but under-estimated the purity of the water, again due to the unusual occurrence of *Amblystegium fluviatile* and *Cinclidotus fontinaloides* (plus *Cratoneuron* spp. and *Schistidium rivulare* – neither MTR scoring taxa) that rarely occur in high altitude, pristine-clean, rivers in the UK. Like the Bistrica River (SLOV-1), a very rich, but quite different, marginal flora.

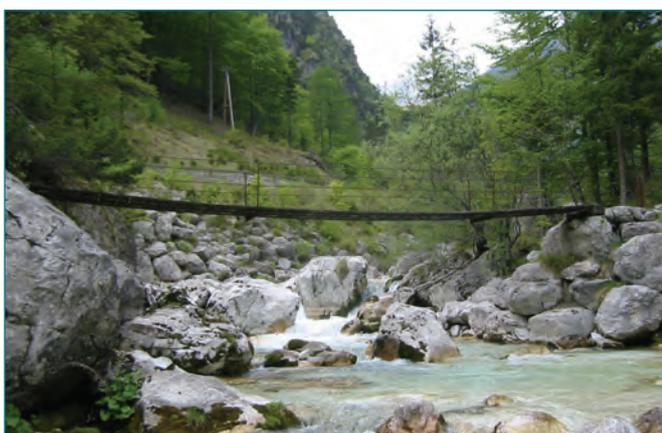
The footbridge at the downstream end of the site

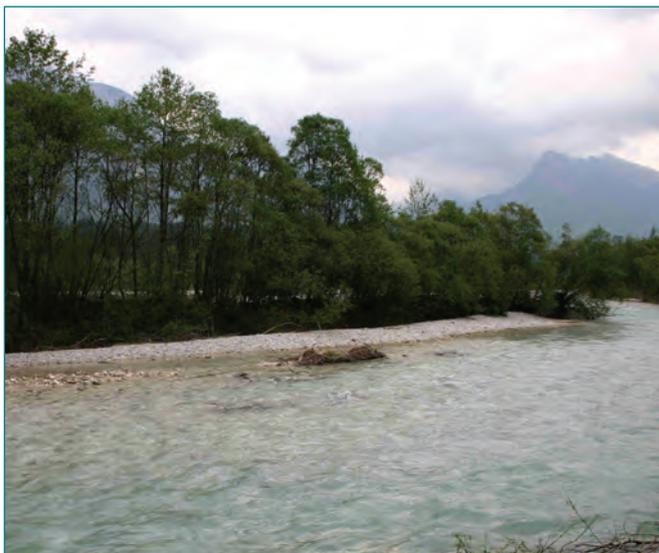
Multi-channels and islands are a key feature of the site. The unstable bed supports no rooted macrophytes

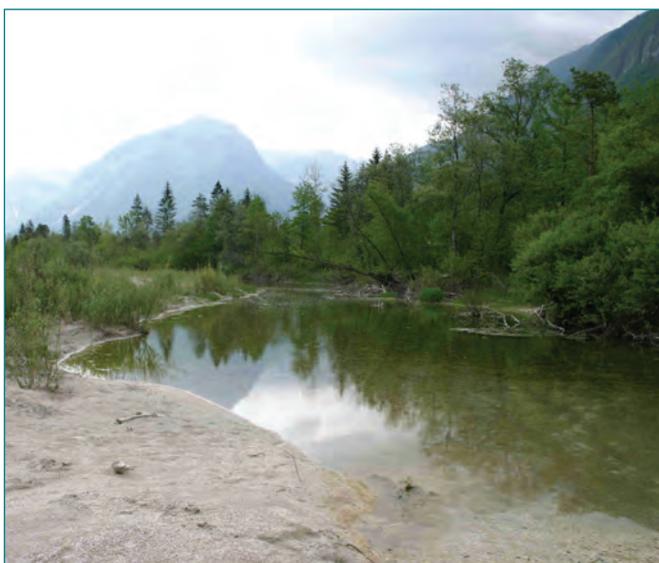
Backwaters provide more stable, and contrasting, habitat to the majority of the site

Very difficult to determine if point bars present. No true riffles in main channel, but woody debris piled high on many bars and margins.

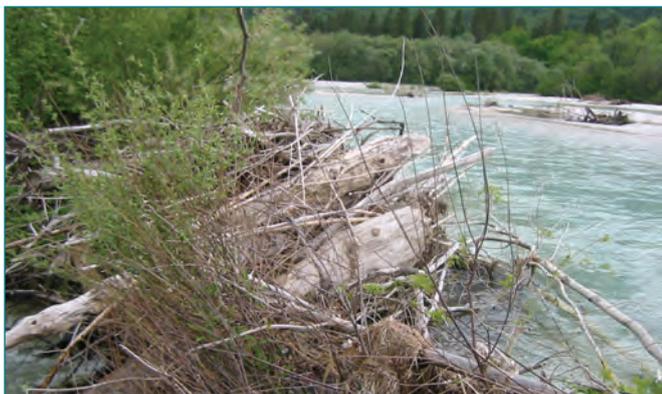
There is extensive woody debris deposited on the margins

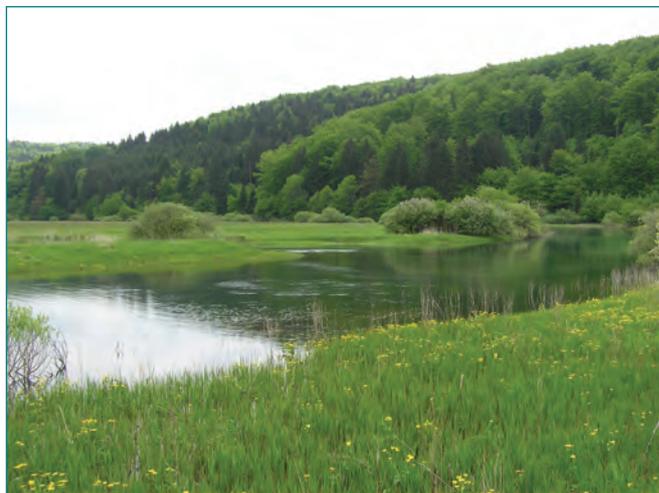
The river has a substantial flow within a few metres of its source

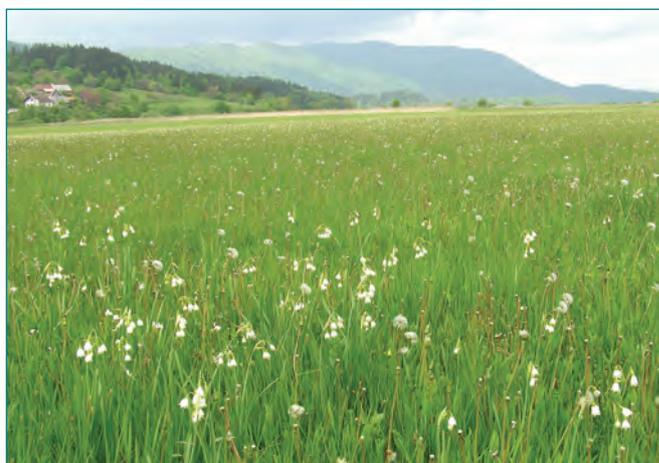
Herb-rich meadows adjacent to the Obrh

Scrub and broadleaved woodland occur in SLOV-6 and SLOV-7, whereas SLOV-8 and 9 are in the wide floodplain which has a very herb-rich meadow, cut once or twice a year. There is a major bridge at the downstream end of SLOV-9.

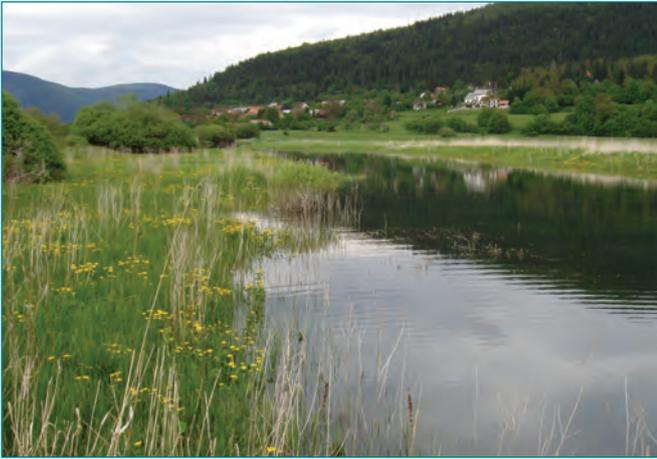
The wide, and rich, riparian habitat forming a two-stage channel

The MTR scores in SLOV 6 & 7 (48 and 45) were probably not a good reflection of the water quality because such a river habitat is not present in the UK, and the base-rich nature of the community lowered the score. The low gradient also resulted in taxa such as *Rorippa amphibia* and *Schoenoplectus lacustris* being present which are taxa more associated with enriched lowland rivers, and so again reduced the MTR score. The National Institute of Biology, Ljubljana, hold macrophyte data for this site; the whole system has been surveyed on several occasions, including when dry.

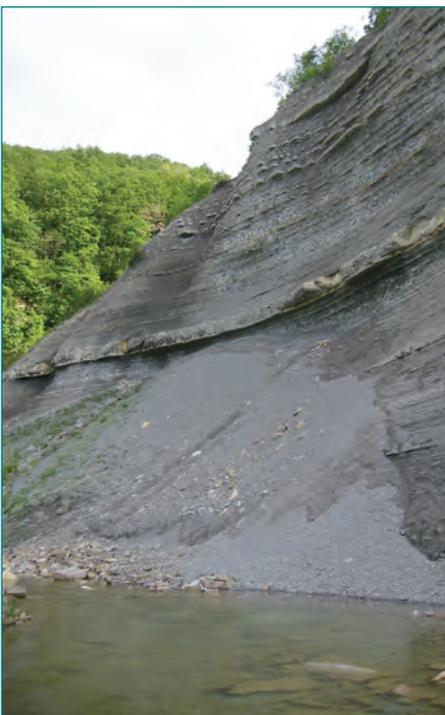
A huge (30m high) cliffs adjacent to the river, with massive slabs of flysch and sandstone

The cliffs provide loose material for the bed, which either get washed away or appear occasionally as discrete gravel deposits, adjacent to bedrock. This geomorphological / geological feature is one reason the river valley is a nature reserve. It is also a Special Area of Conservation under the Habitats Directive.

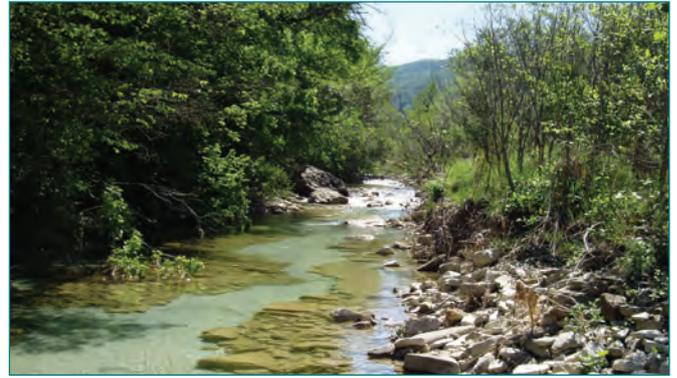
An unusual mixture of bedrock and cobble bars

A distinct step-like flow sequence over boulder/cobble substrate is equivalent to riffles; these were counted as such, so care is needed over interpretation. Broad-leaved and conifer woodland mixture on valley slopes (beech, hazel, oak) with alder blackthorn prevalent in the riparian scrub.

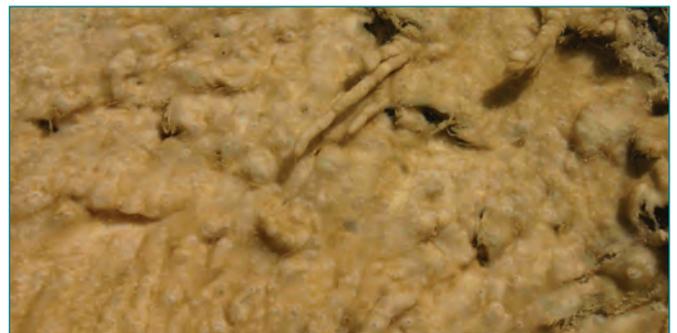
No truly aquatic plants recorded, but 100% of the submerged channel substrate, including bedrock, covered by thick diatom growth when terrestrial species not present.

Diatom slime covers the bed

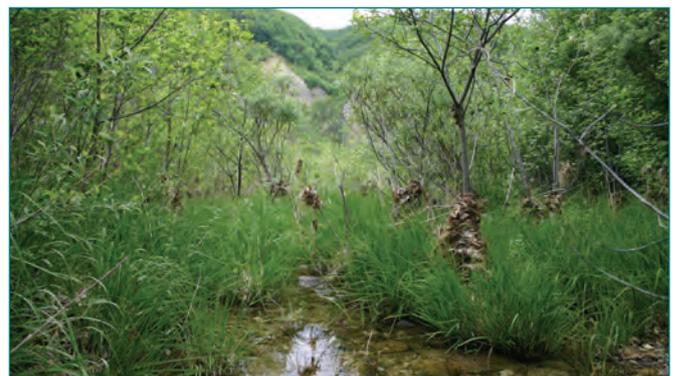
Very unusual flora reflects the intermittent nature of flow, the very calcareous substrate, and also the need for species to be able to be submerged for long periods in the early part of the growing season, and then withstand extreme desiccation later. Even bryophytes were rare. Grasses, herbs associated with river margins, and the sedges *Carex viridula* and *C. panicea* dominated a 'green' river bed. An MTR survey was carried out, but it produced a meaningless score of 60, based on just three plant species. The flora indicates drying, and baking, of the majority of the bed for much of the summer growing period.

Scrub and sedges dominate the centre of the channel

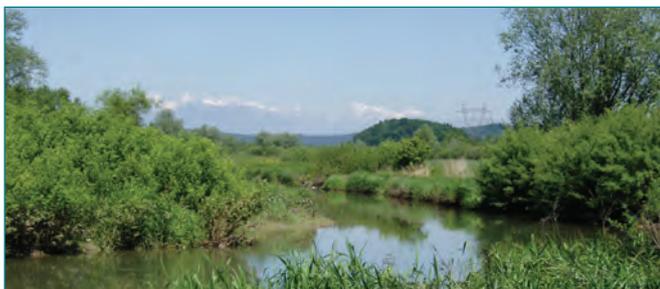
In the downstream site a silty point bar is developing in an otherwise relatively uniform channel

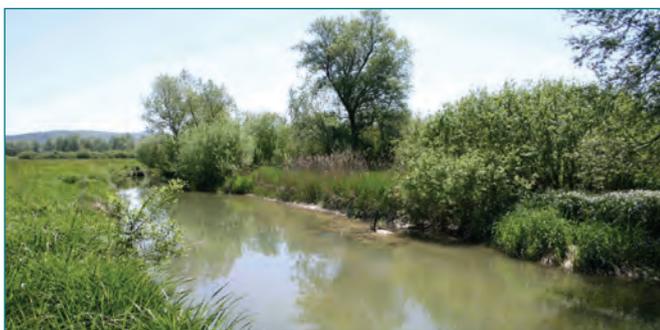
As the river appears to be recovering from widening and deepening, a 'berm' is developing and a dense riparian zone of sedges and willow scrub thrives

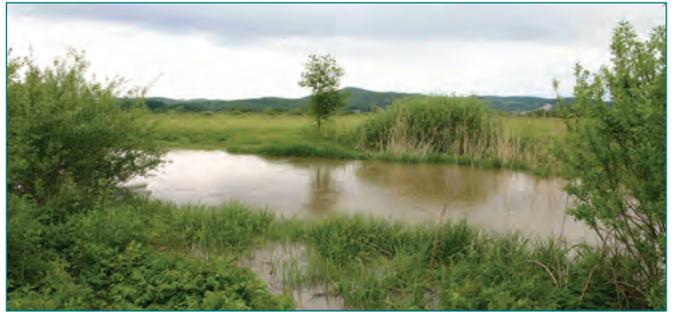
Spate flow conditions on 18 May (which prevented planned survey that day) show clearly the flooding of a natural berm/terrace

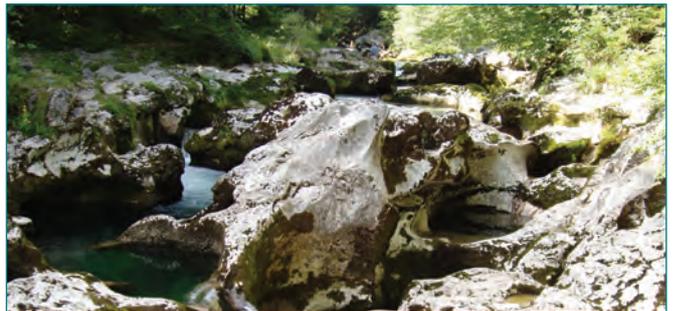
A small alpine stream flowing in a deep (450m), steep-sided wooded valley. A narrow, 20m deep ravine section (spot-checks 2 and 3) opens out into a bedrock/boulder channel. The bedrock in the ravine section is extensively scoured and sculptured by the calcareous rocks being dissolved forming a series of plunge pools, some more than 3m deep, with gravel at the bottom. A marshy area with small pools adds to the habitat diversity.

Plunge pools and rock hollows, contrasting features in the bedrock dominated river

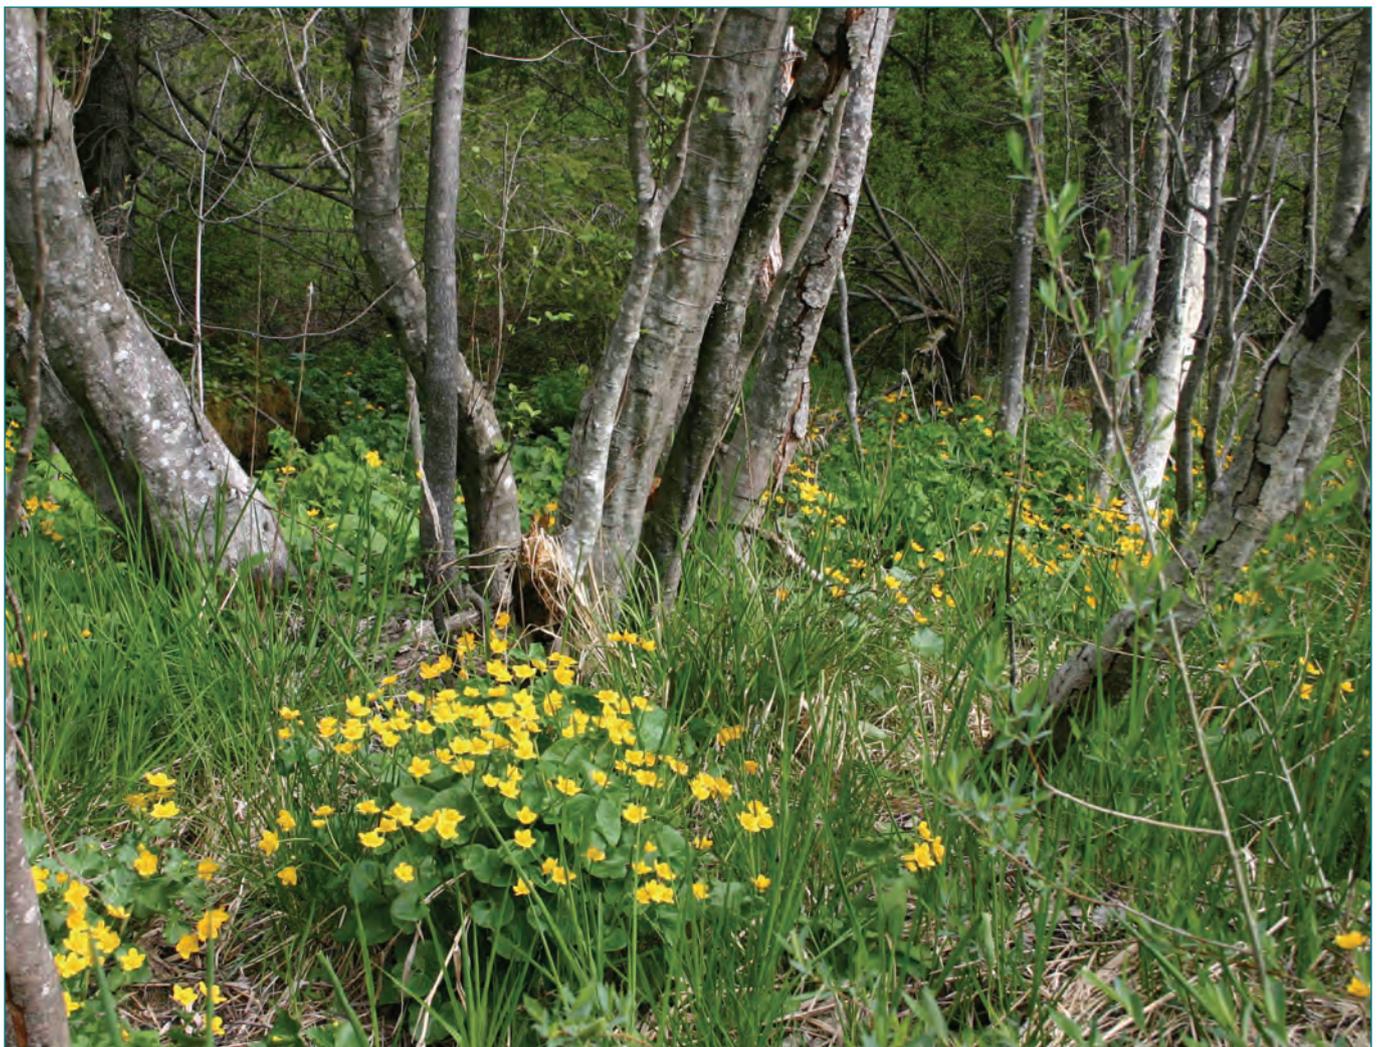
Wetland habitat - a scoring component of the HQA system

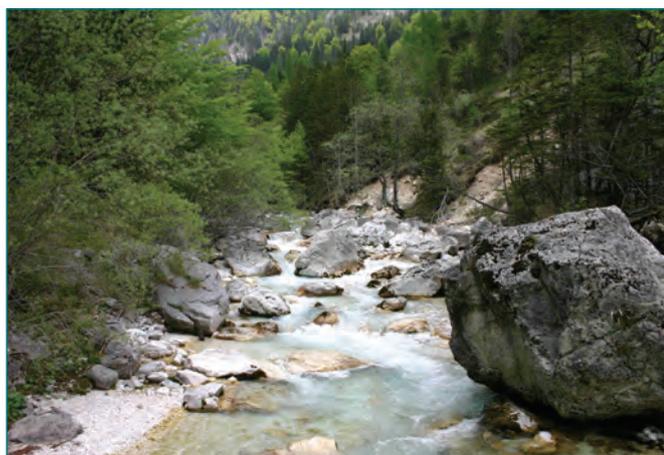
More clarity is required when recording native conifer woodland

Coniferous woodland (CW). The current wording should be changed to reflect the mixture of trees more accurately. For instance, "BL" is described as "predominantly broad-leaved", whilst CW just indicates "native conifers". It is recommended that the text is amended so that CW refers to "predominantly native conifers". It would also be useful to encourage surveyors to record the approximate mix (e.g. % pine, larch, spruce, birch, beech, etc.) in their notes.

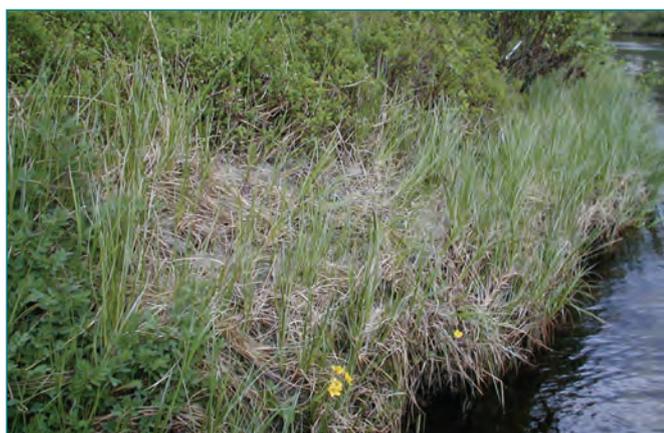
Natural berm on a large river in Finland

Natural berm (NB). This is a common feature of many European rivers. The terraced, composite, bank form makes "bankface" and "bankfull" very difficult to determine. We need to clarify when the berm becomes a terrace because this will influence vegetation structure and land-use records for spot-checks (see section E on form). It is recommended that similar differentiation is used as for mature island, where vegetation on terraces (as opposed to low-level berms) will include shrubs and saplings. At this stage the feature becomes a terrace and the shrubs etc become the banktop land-use. A terrace profile could be added to the form.

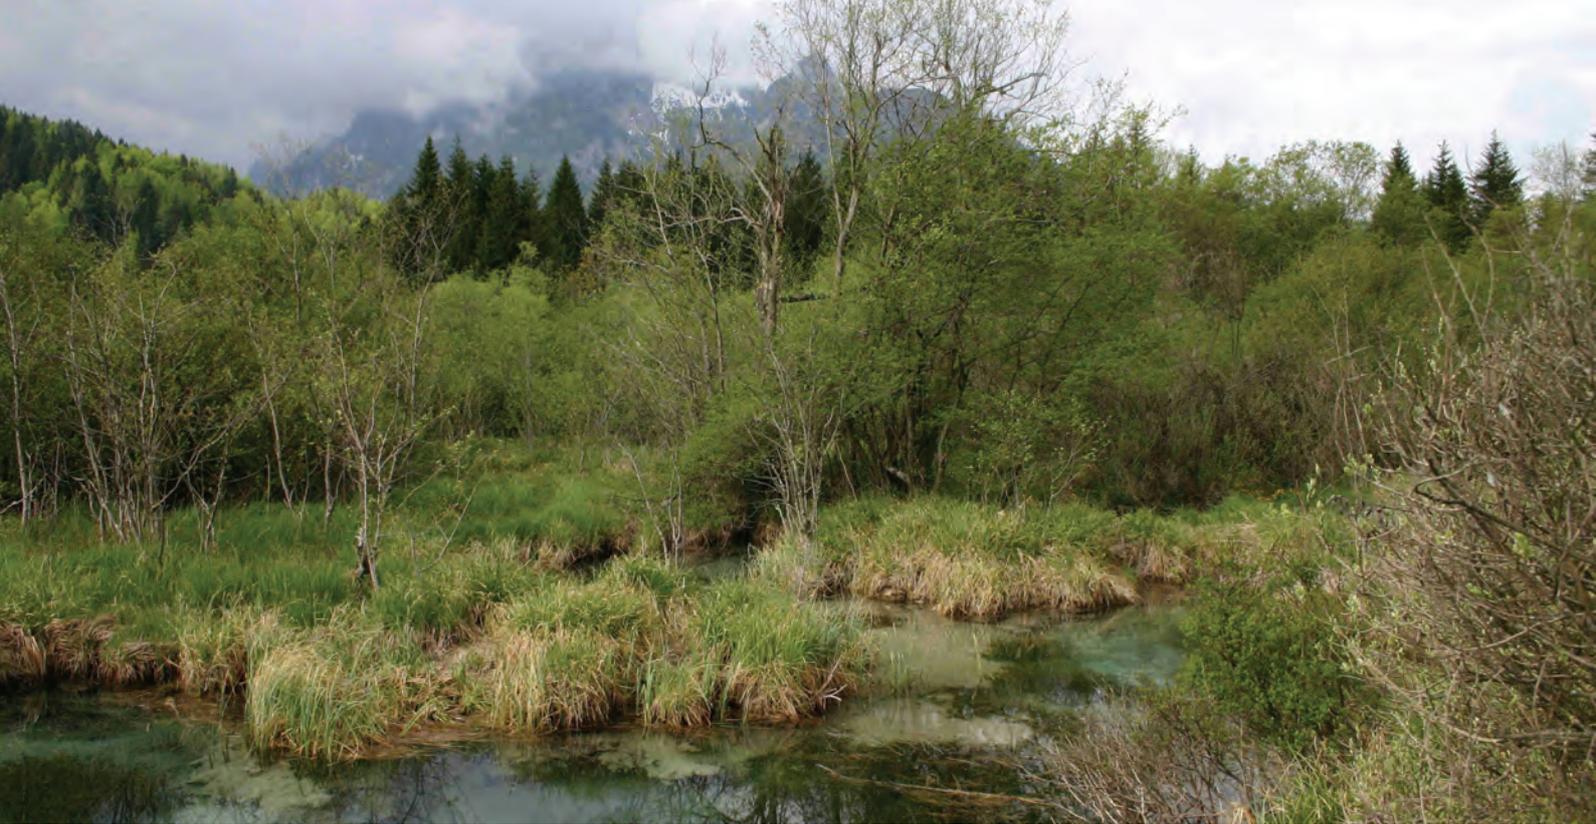
The Sava River has a distinct riparian zone of wet woodland

Riparian zone. This should be recorded in the special features section given its importance. Clear distinction is needed, because it must be restricted to habitat (largely wetland or scrub) that occupies the composite/terraced bank, characteristic of many European rivers. It is recommended that clear descriptive examples are used for UK purposes (e.g. braided channels with wet woodland).
