RIVER HABITAT SURVEY IN SLOVENIA

RESULTS FROM 2005

A report by Paul Raven¹, Nigel Holmes², Hugh Dawson³ and David Withrington⁴

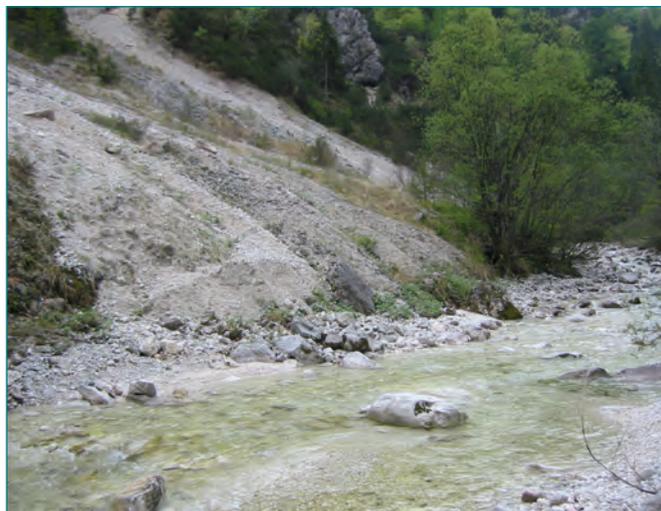
Rock and scree needs to be able to contribute to the 'land-use' scoring section of HQA

HQA scoring – land use within 50m. Currently a score of 7 is allocated if broadleaved woodland, coniferous woodland or wetland, alone or together, are the only categories recorded for a bank. It is recommended that when scrub and shrubs (SH), or rock, scree or sand dunes (RD), are obviously part of the natural riparian zone, they are added to the scoring list. For SLOV-2, which is completely semi-natural, under the current scoring system HQA sub-score for land use would be 4; for the recommended version, and one used in this report, it is 14.

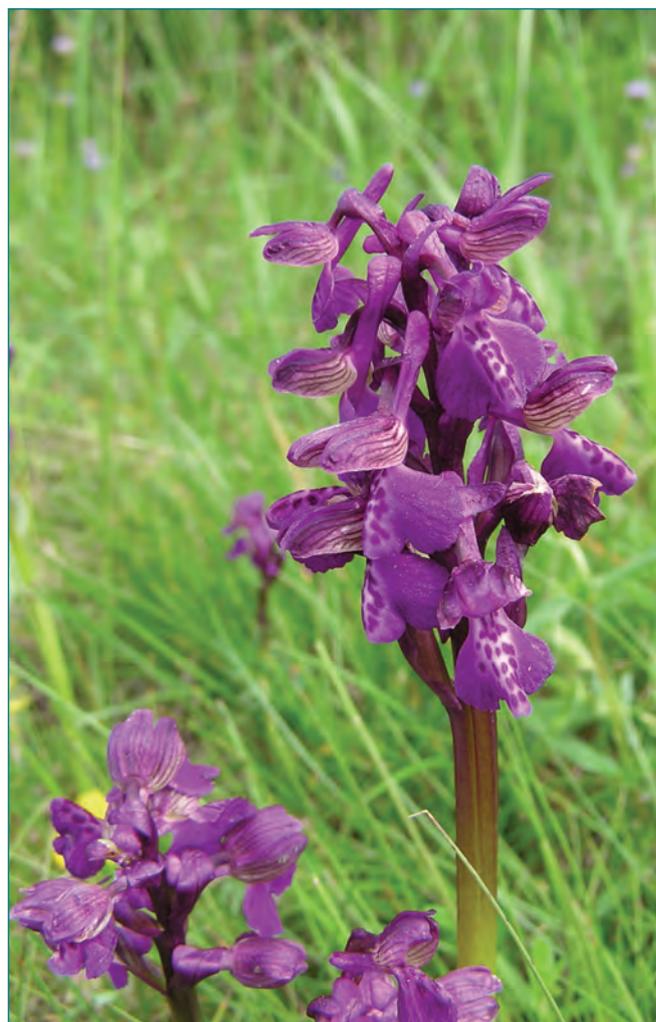
Herb Rich grasslands need to be added to the 'special features' section of the HQA scoring system

It is recommended that the following categories are added: riparian zone; herb-rich meadows. For the purposes of this study, they were included in the HQA score.
