ASiantaeth yr
Amgylchedd
Environment
Agency

River Habitat Survey in Britain and Ireland

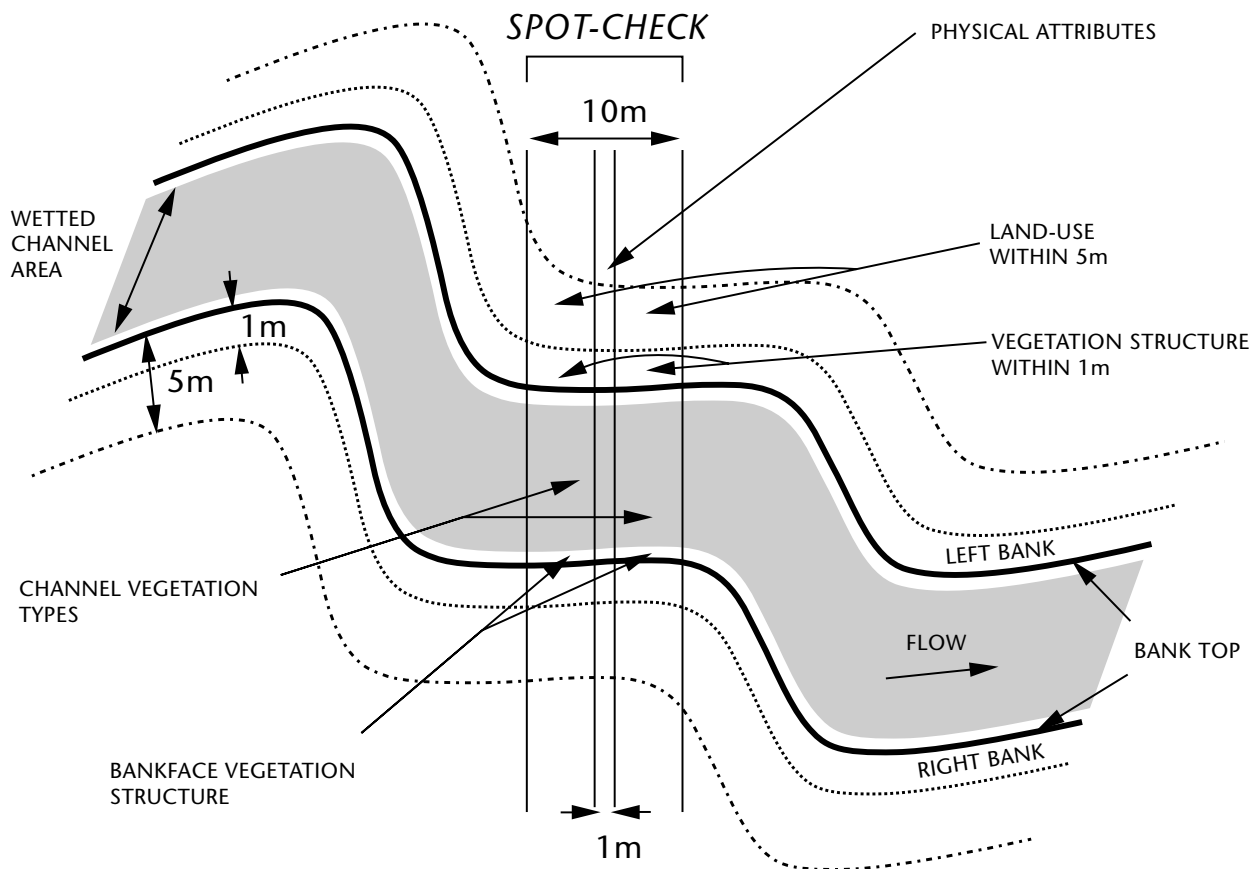
Figure 1 Diagram showing dimensions for spot-checks

For physical attributes (E), use a transect 1m wide at each spot-check across the channel. For land-use, vegetation structure and channel vegetation types (Sections F and G on page 2), use a 10m wide transect, at the same location (see Figure 1).

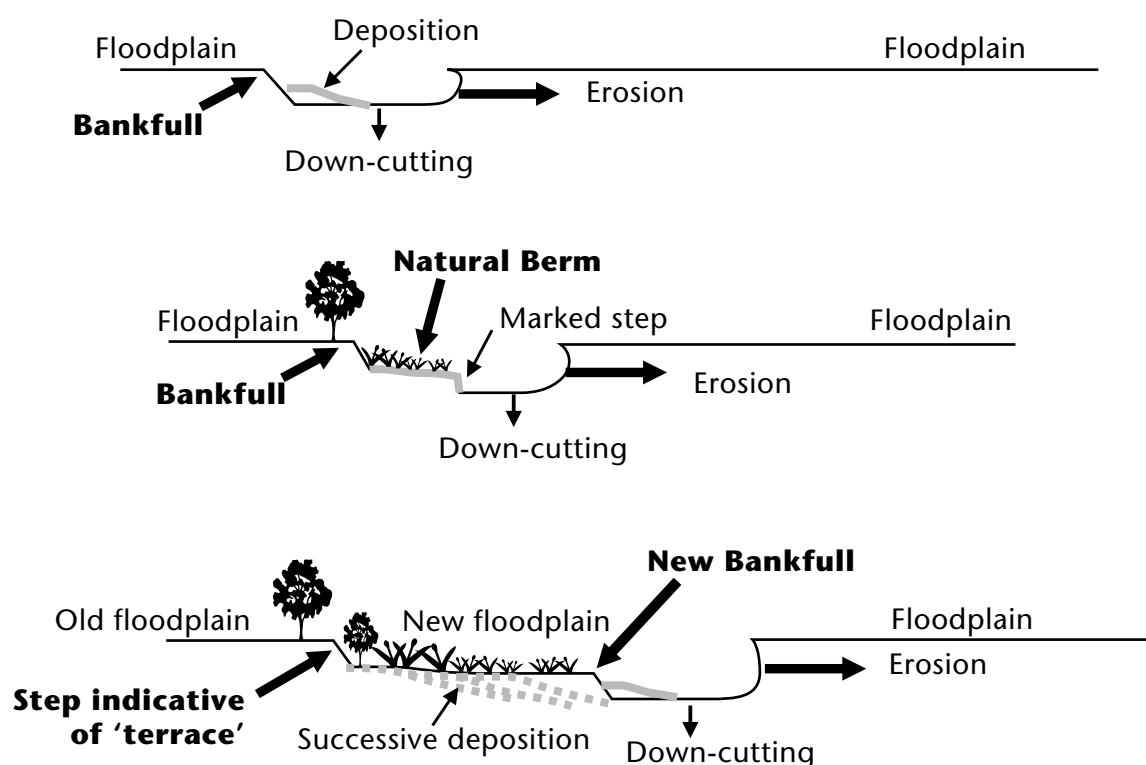
Figure B1 Sequence of natural berm and terrace formation

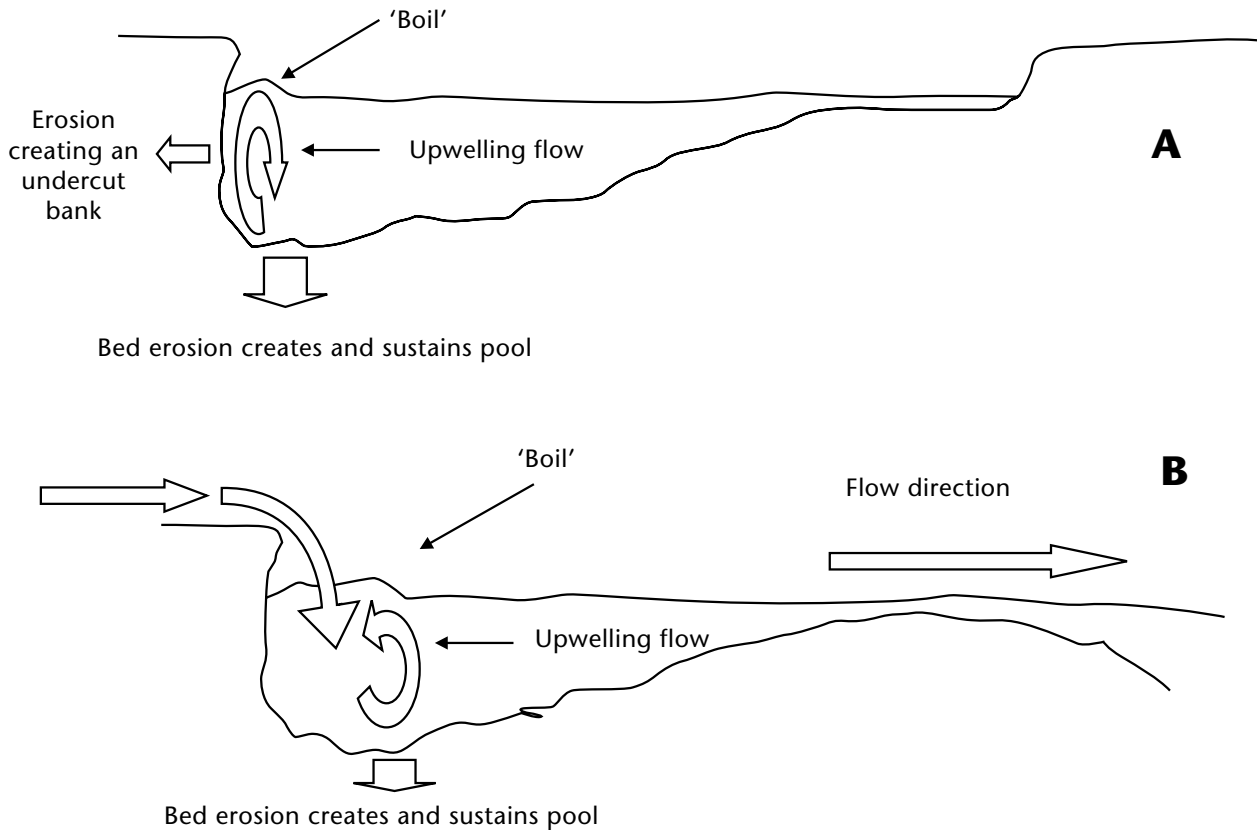
B: waterfall or weir (long-section)

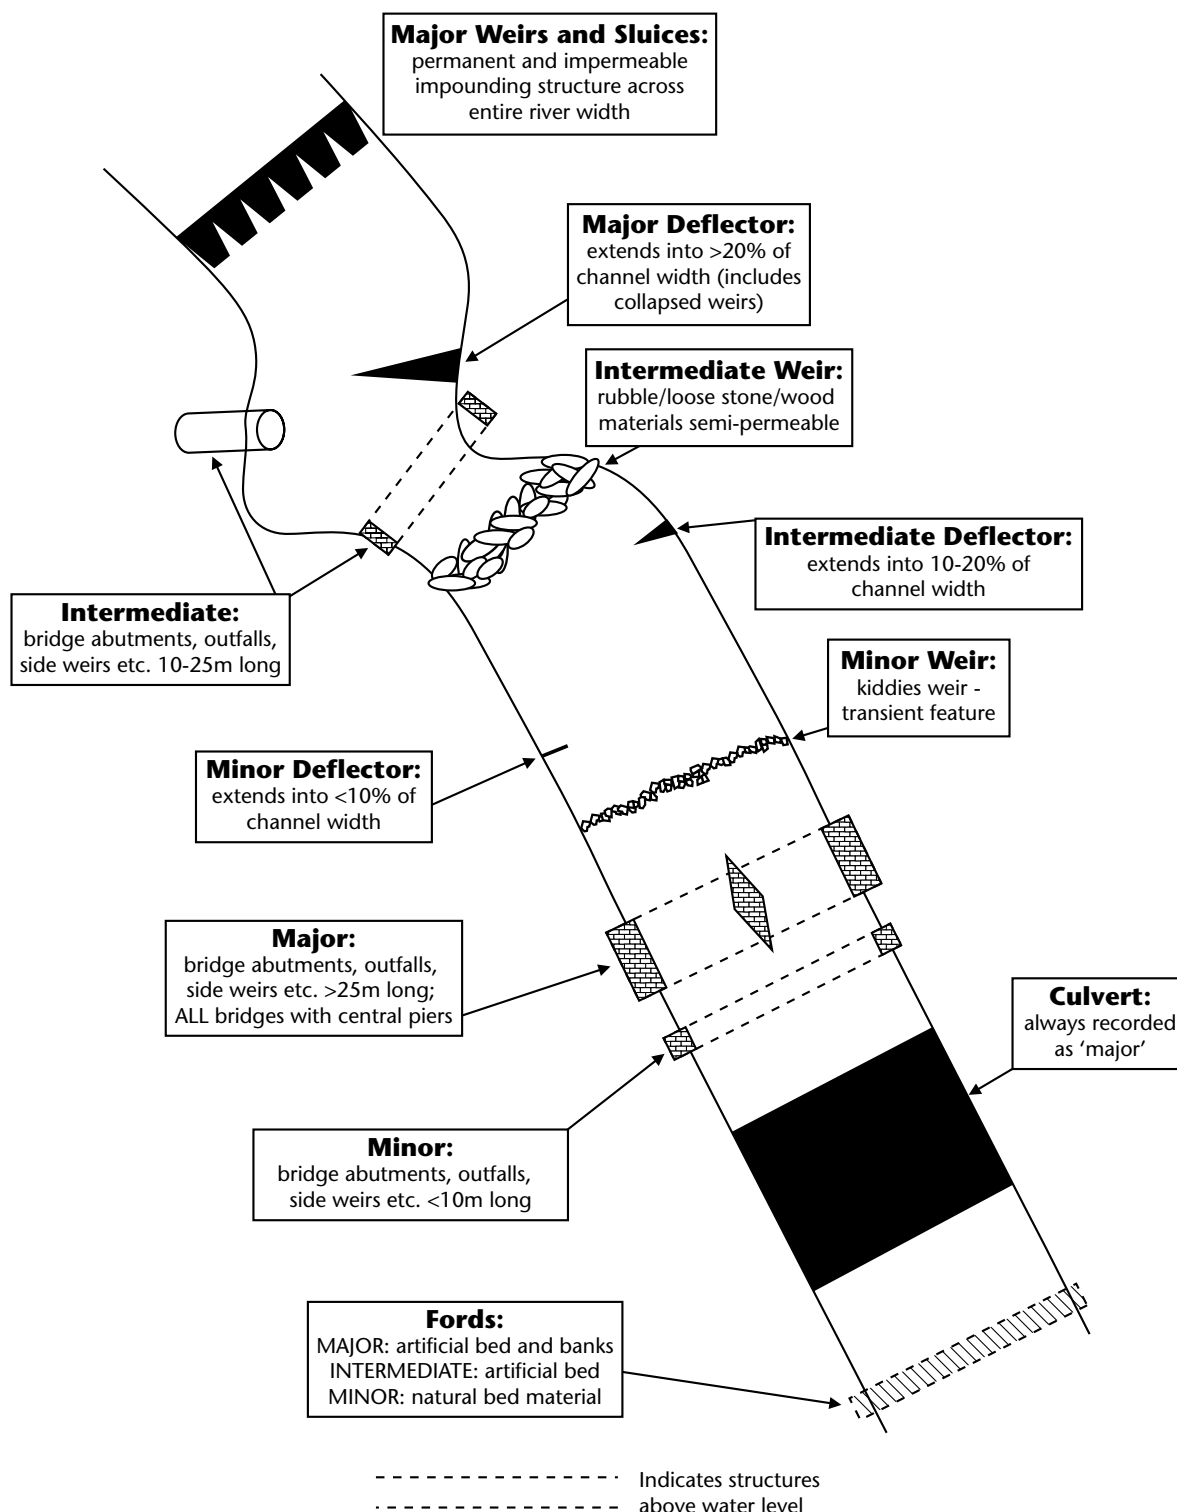
Figure D1 Illustrated definitions of artificial features

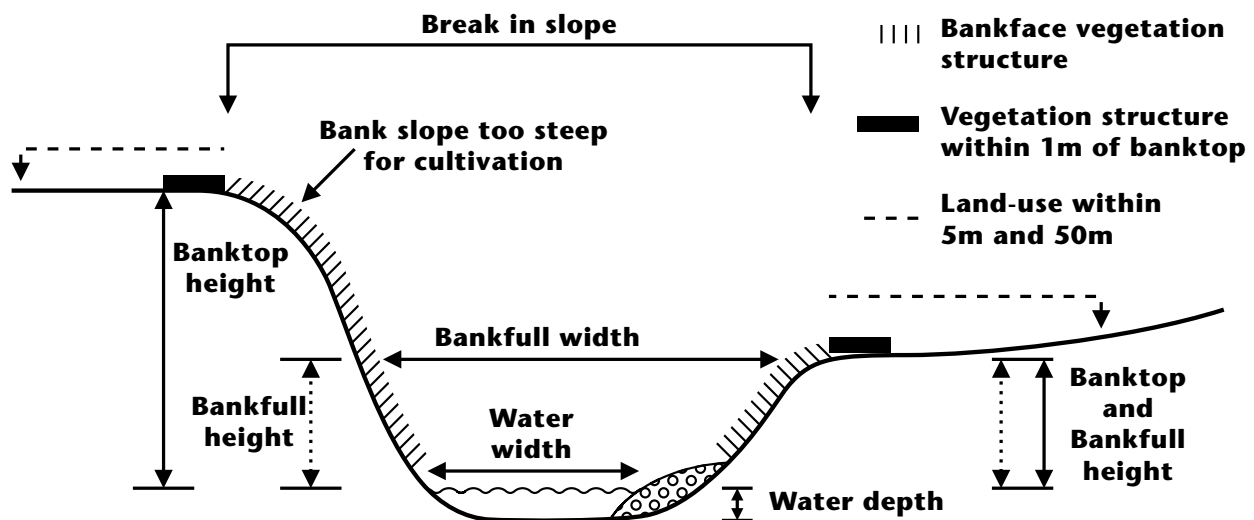
Figure E1 Cross-section of channel showing definitions used to define where spot-check recording and channel dimensions measured

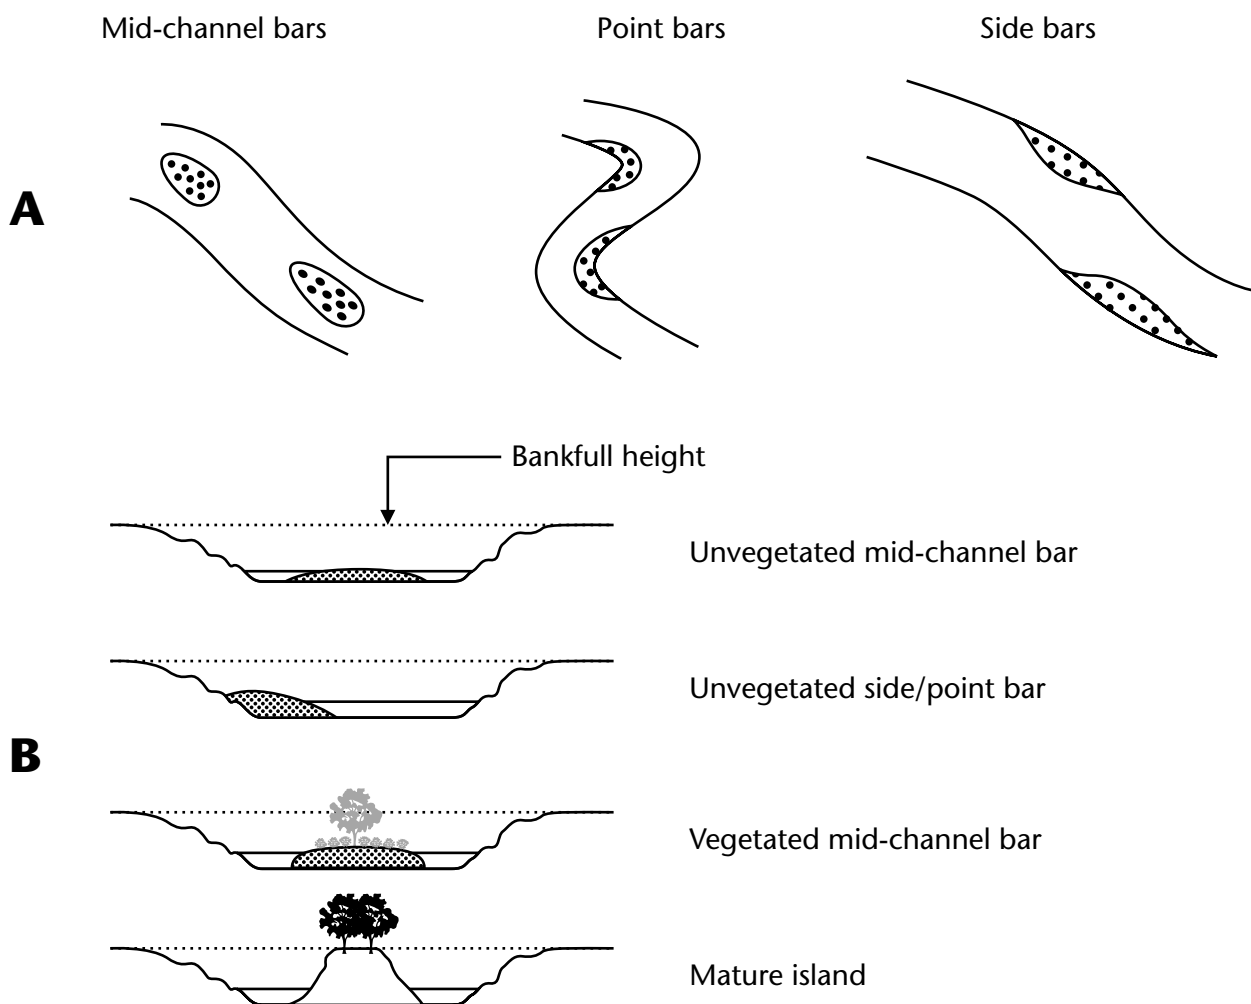
Figure E3 Location of bar features recorded in RHS:
A - planforms
B - cross-sections

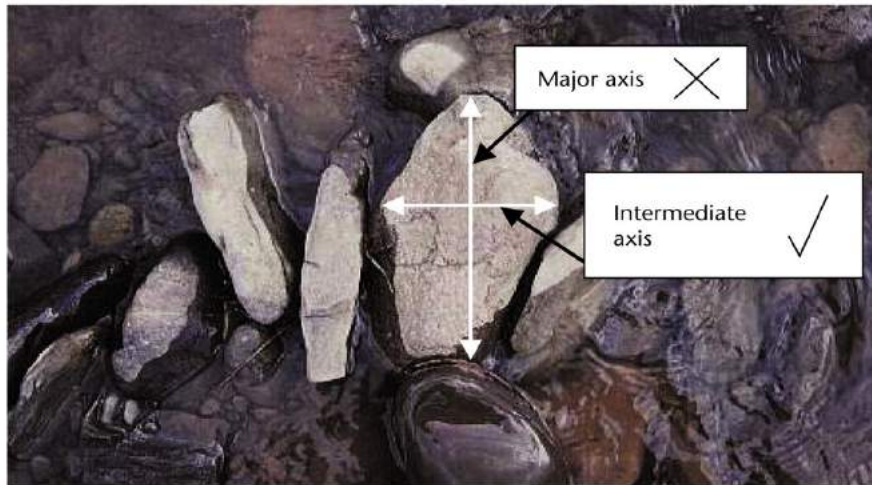
Figure E5 Illustration of correct use of the 'intermediate axis' for channel substrate assessments in RHS

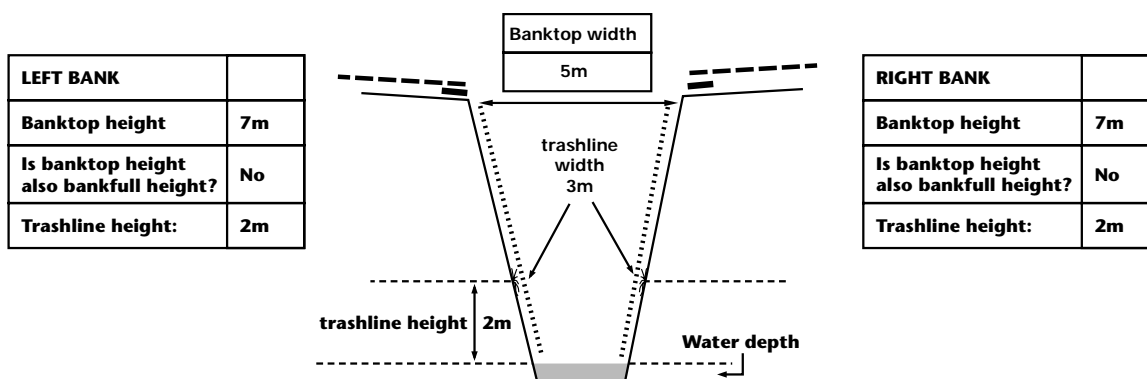
Gorge

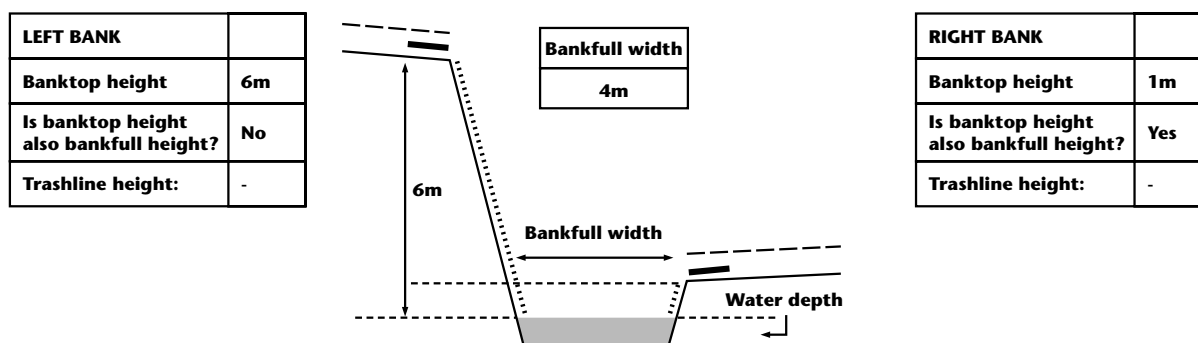
Asymmetrical channel or valley

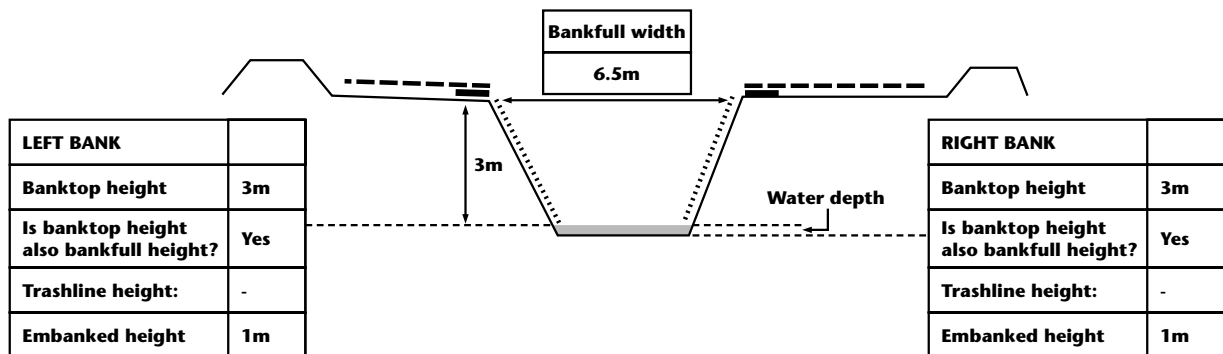
Channel with set-back embankments

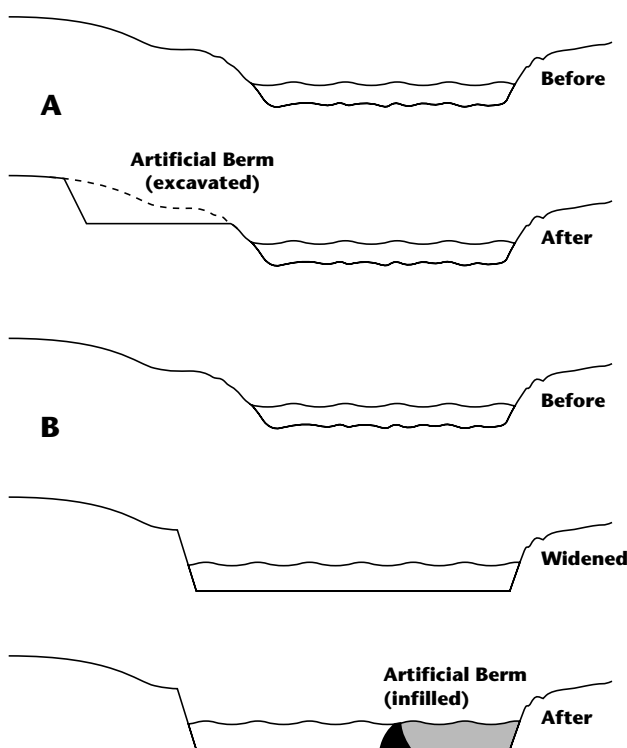
Figure I1 Artificial two-stage channel – berm formation through:
A - bank excavation
B - channel infill

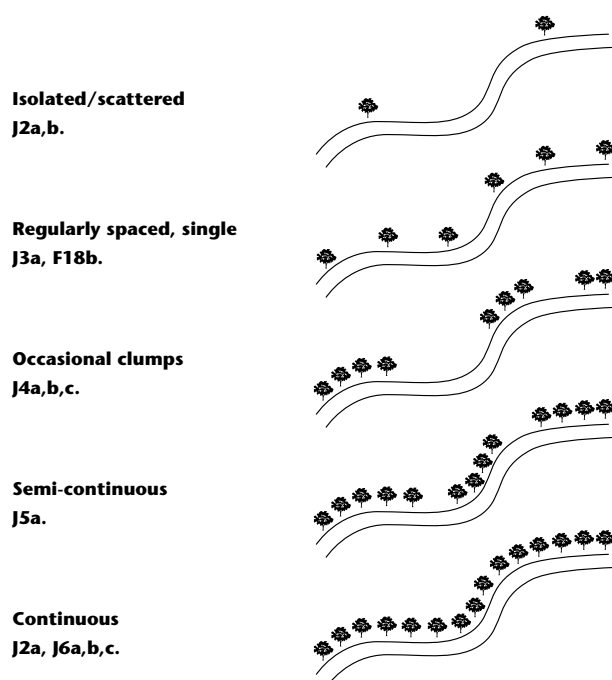
Figure J1 Illustration of RHS recording of bankside trees

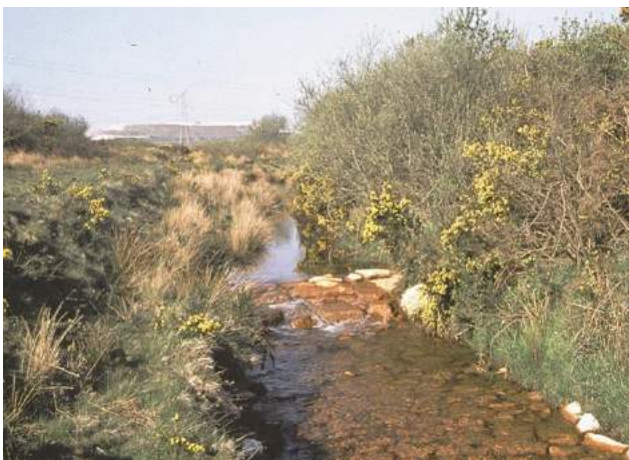
D1c Major weir/sluice – despite small size, the weir structure is 'fixed,' and does not leak water. Note scrub and short grass on right, and short grass and tussocky tall grass on left – both with simple bank vegetation structure. Water upstream is impounded.

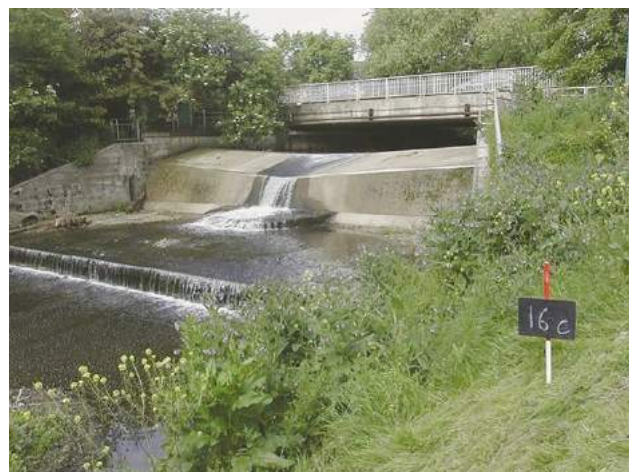
D1d Major weir/sluice – example of a complex weir structure used for measuring flow. Note also an intermediate bridge.

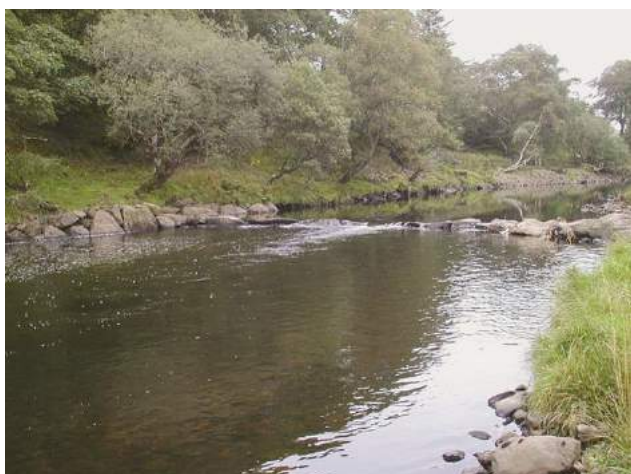
D1e Intermediate weir – boulders are not cemented, and water can leak through the fissures.

Intermediate: semi-permeable, fixed, structures controlling water levels; **extending across the entire width of the channel but permeable enough to allow some water to flow through them**. Commonly made from loose rubble, inter-locked boulders and, less commonly, logs. 📷 D1e,f.

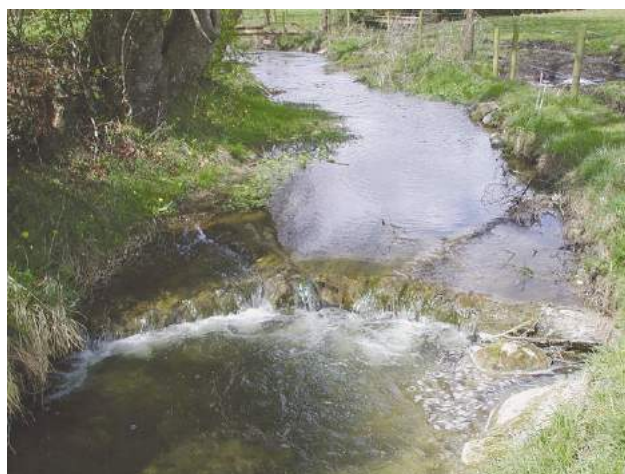
D1f Intermediate weir – wooden log construction, and water can leak through gaps.

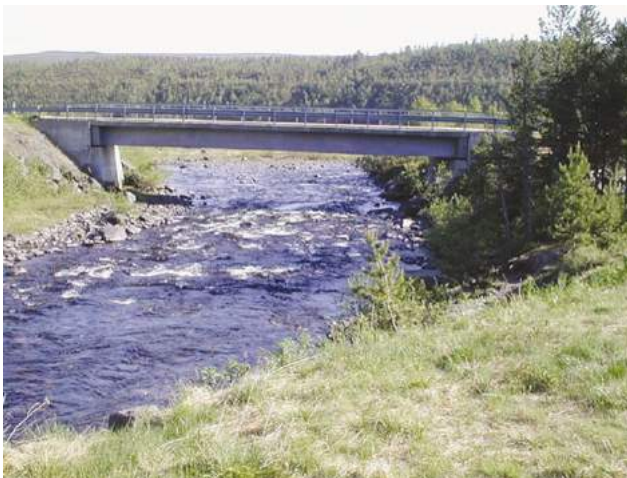
D3c Intermediate bridge – no central piers, and with bank-side abutments 10-25m long. Note broken standing waves.

Intermediate: road or rail bridges **without any in-river supports**, and with bank abutments occupying 10-25m of the bank. 📷 D3c.

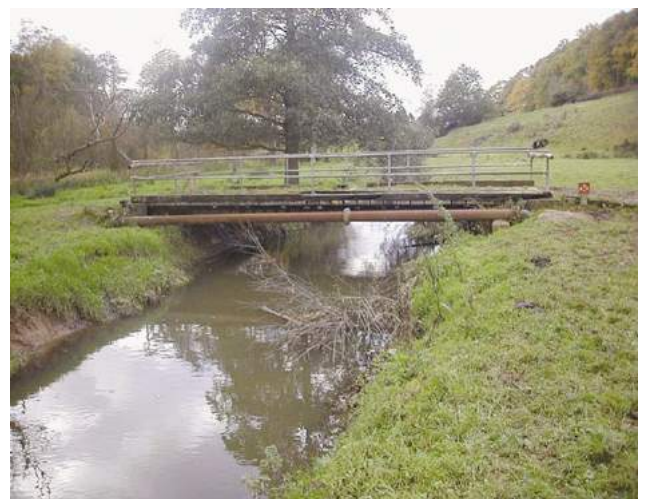
D3d Minor bridge – farm track bridges <10m wide are recorded as 'minor'.

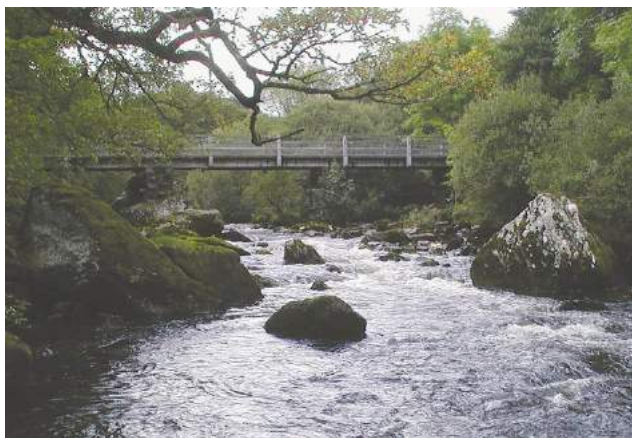
D3e Minor bridge – pipelines crossing rivers, if lacking central piers, are recorded as minor bridges. See also Na. Note exposed boulders and broken standing waves.

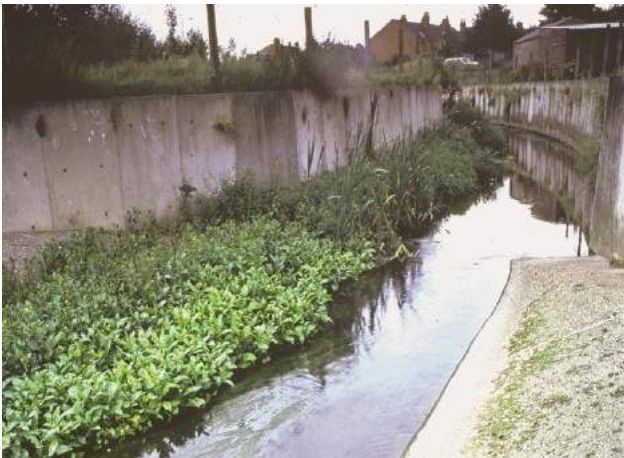
E1Hb Concrete bank material. This example illustrates an artificial berm as habitat creation as part of a flood defence scheme, and this should be noted in Section P.

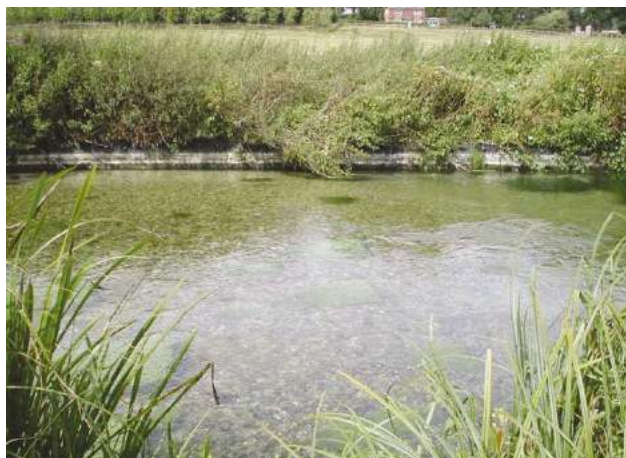
E1Oa Fabric bank material – non-degradable sheet ('nicospan'). Note tall herb bank vegetation above, so record structure as 'simple'.

Synthetic (usually permeable geo-textile) bank protection fabric often used in conjunction with soil back-fill. Always non-biodegradable, with the prime function of bank support and protection from erosion. Includes materials such as plastic, and proprietary products such as 'enkamat' and 'nicospan'. 📷 E1Oa.

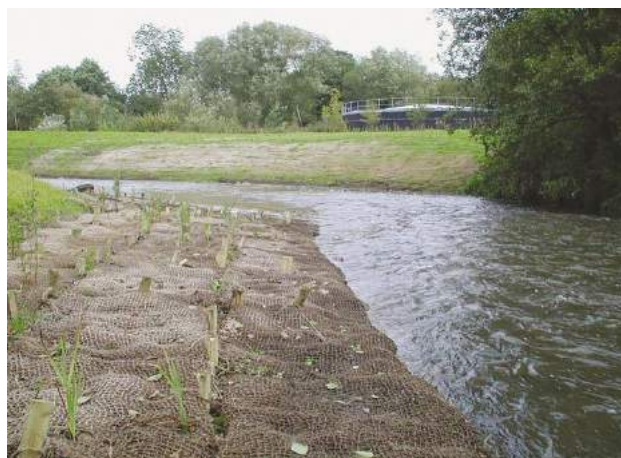
E1Pa Bio-engineering bank materials – bio-degradable matting with vegetation planting. Record bank vegetation structure as 'bare'.

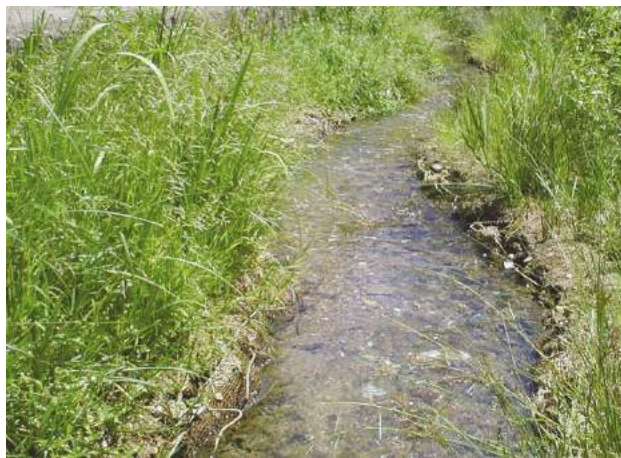
E1Pe Bio-engineering bank materials – here bio-degradable hessian has been used in combination with reed planting and other vegetation.

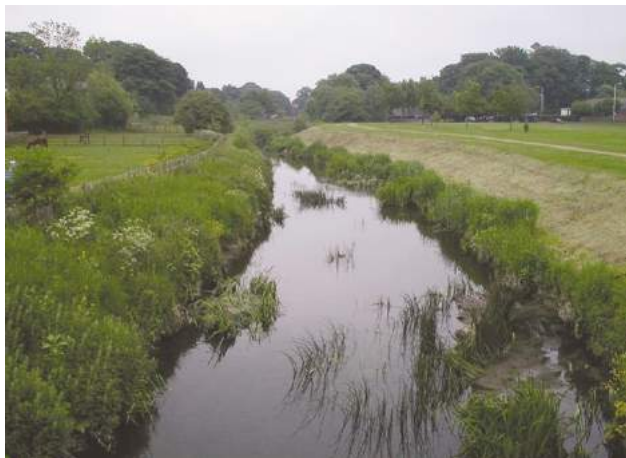
E2Aa Resectioned (reprofiled) bank – tell-tale smooth (trapezoidal) slope even though undertaken many years ago; river also over-deepened, with tell-tale ‘step’ in the profile where bed material at the base of the bank removed. See also A1a, D8a,b,c, E3Da, I6b.

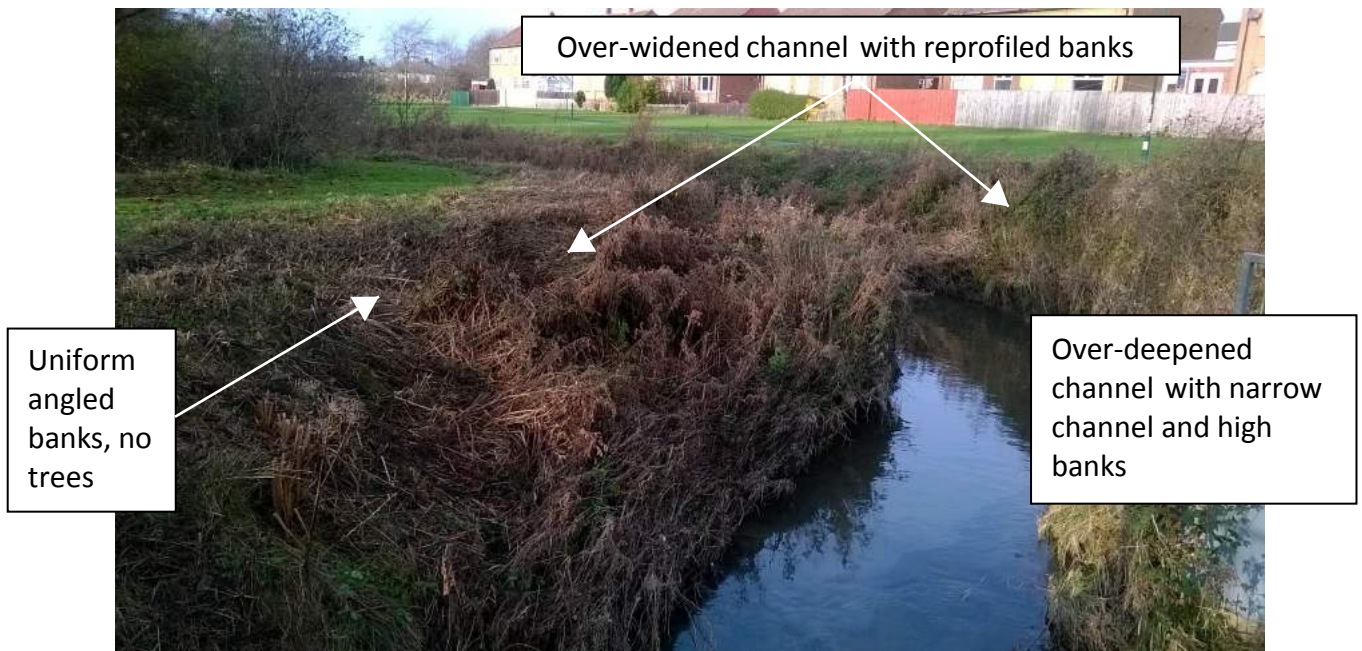
Resectioned channel - over-deepened, with resectioned banks

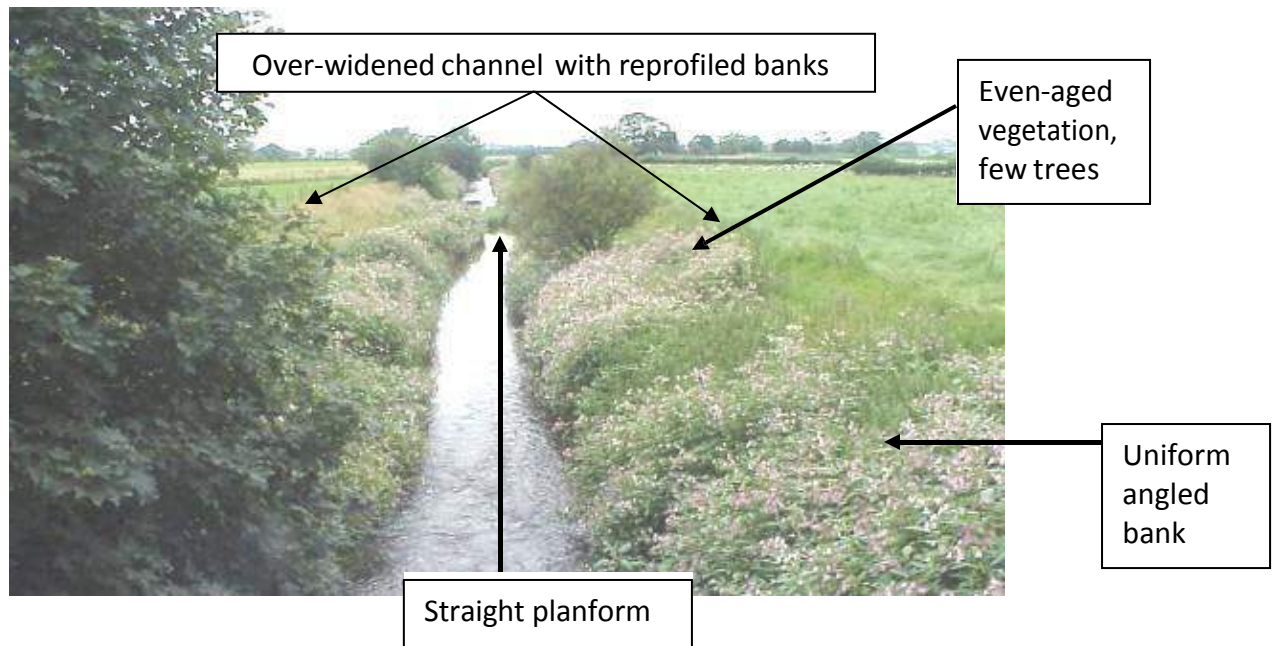
Resectioned channel – realigned and over-deepened with resectioned banks

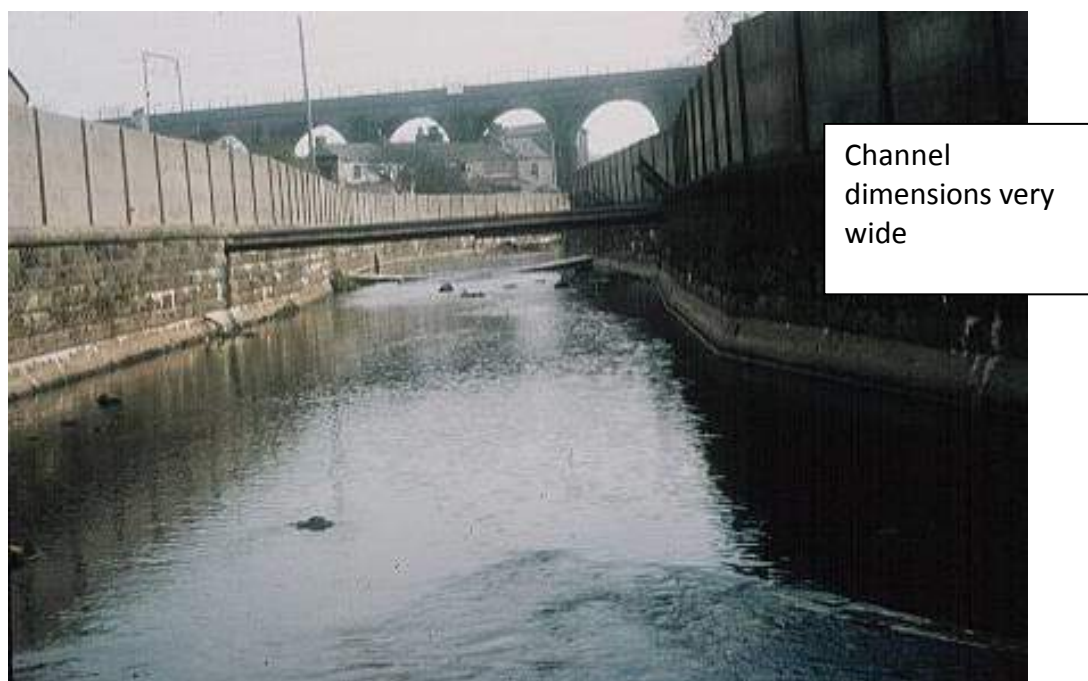
Resectioned channel – over-widened

Record channel resectioning under channel modification in the spot-checks:

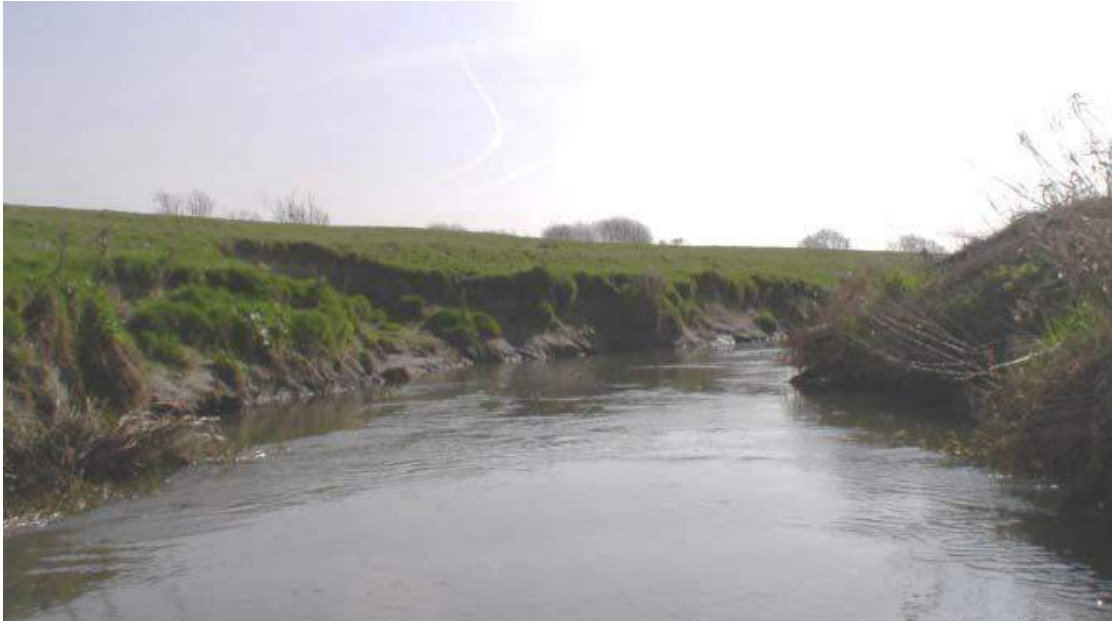
Naturalising banks with over-deepened channel

In this example, the river has had both banks and channel resectioned in the past. The channel is still clearly over-deepened and realigned, but the banks are beginning to naturalise in places (note the presence of erosion and slumping on the left). Where resectioning is no longer visible, record NO obvious modification in the spot-checks.

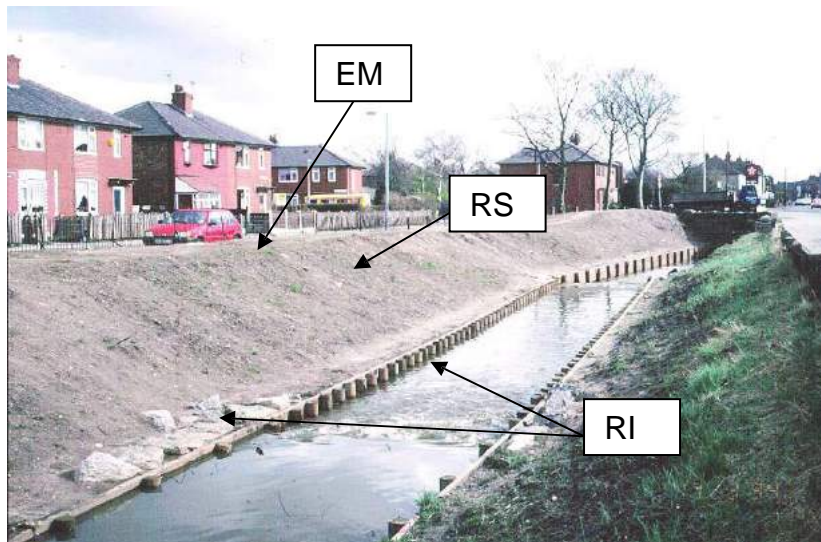
On this urban river section, the left bank has been raised (look at the level of the car) and reprofiled. Record both EM and RS in the spot-checks. As bank reinforcement is also visible at the toe of the banks, you should also record RI.
